# Manhole Inspection Report

Date:	<b>04/05/2018</b>	Weather:		Coding:	<b>RZMACP</b>
MH#:	<b>M-607-033</b>	Owner:	<b>NA</b>	Len. Surveyed:	<b>6.8</b>
P.O.#:		Surveyor:	<b>John Kuglmaier</b>	Rim to Invert:	<b>7.3</b>
Customer:		Cert. #:	<b>U-1215-07002349</b>	Wall Material:	<b>Concrete (reinforced)</b>

Street:	<b>14th St. and Wisconsin St.</b>	Project:	<b>Hobart, IN</b>
City:	<b>Hobart, IN</b>	GPS Northing:	<b>0.0</b>
Location:		GPS Easting:	<b>0.0</b>
Drain Area:	<b>Southwest</b>	GPS Accuracy:	<b>Nearest Meter</b>
Cover Shape:	<b>Circular</b>	Evidence of Surcharge:	<b>No</b>
Cover Size:	<b>22.5</b>	Potential for Runoff:	<b>None</b>
Comments:

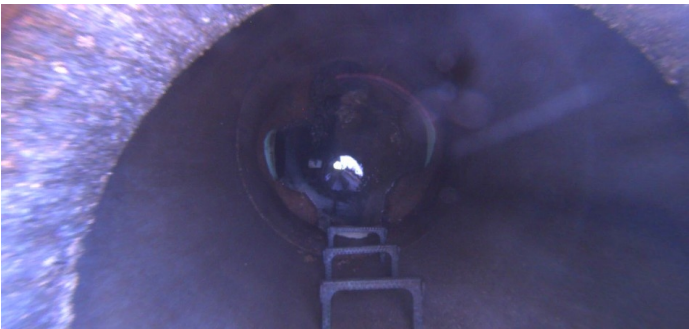
Code: **MGP**  
 Description: **General Photo**

Distance (ft): **.0**  
 Structural Grade: **0**  
 O&M Grade: **0**  
 Clock Start/From:  
 Clock To:  
 1st Value:  
 2nd Value:  
 Value Percent:  
 Step: **NO**  
 Remarks:

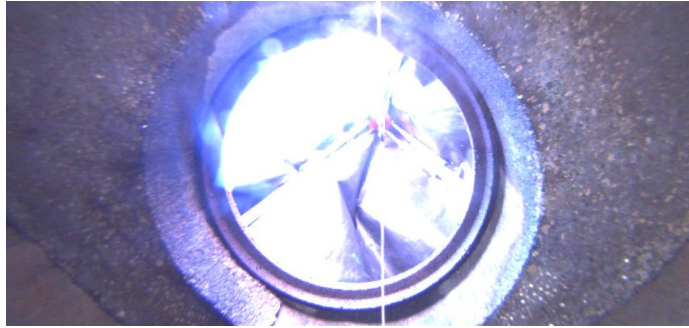
Code: **MGP**  
Description: **General Photo**

Distance (ft): **2.5**  
Structural Grade: **0**  
O&M Grade: **0**  
Clock Start/From:  
Clock To:  
1st Value:  
2nd Value:  
Value Percent:  
Step: **NO**  
Remarks:

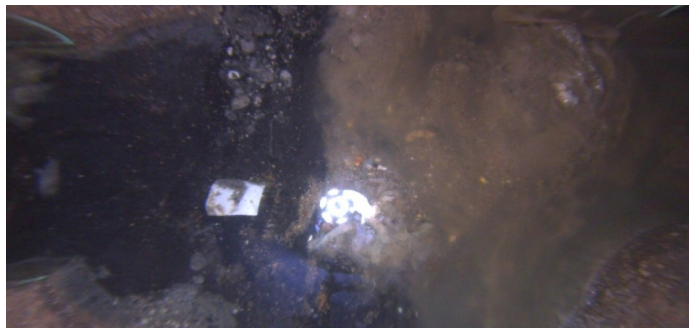
Code: **MGO**  
Description: **General Observation**

Distance (ft): **5.6**  
Structural Grade: **0**  
O&M Grade: **0**  
Clock Start/From:  
Clock To:  
1st Value:  
2nd Value:  
Value Percent:  
Step: **NO**  
Remarks: **Ins. Comp.**
