# Manhole Inspection Report

Date:	<b>04/04/2018</b>	Weather:		Coding:	<b>RZMACP</b>
MH#:	<b>M-607-034</b>	Owner:	<b>NA</b>	Len. Surveyed:	<b>9.9</b>
P.O.#:		Surveyor:	<b>John Kuglmaier</b>	Rim to Invert:	<b>10.1</b>
Customer:		Cert. #:	<b>U-1215-07002349</b>	Wall Material:	<b>Concrete (reinforced)</b>

Street:	<b>Washington St. and 14th St.</b>	Project:	<b>Hobart, IN</b>
City:	<b>Hobart, IN</b>	GPS Northing:	<b>0.0</b>
Location:		GPS Easting:	<b>0.0</b>
Drain Area:	<b>Southwest</b>	GPS Accuracy:	<b>Nearest Meter</b>
Cover Shape:	<b>Circular</b>	Evidence of Surcharge:	<b>Yes</b>
Cover Size:	<b>22.5</b>	Potential for Runoff:	<b>None</b>
Comments:

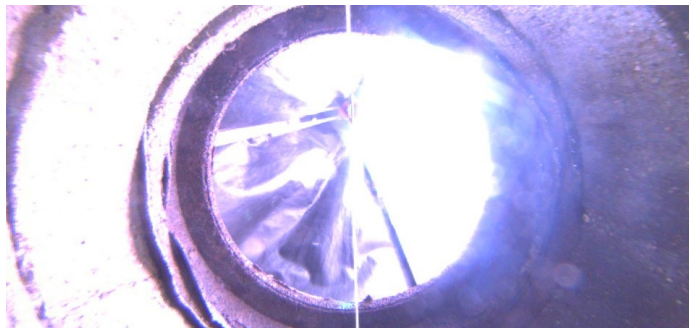
Code: **IS**  
Description: **Infil Stain**

Distance (ft): **2.0**  
Structural Grade: **0**  
O&M Grade: **0**  
Clock Start/From: **10**  
Clock To:  
1st Value:  
2nd Value:  
Value Percent:  
Step: **NO**  
Remarks:

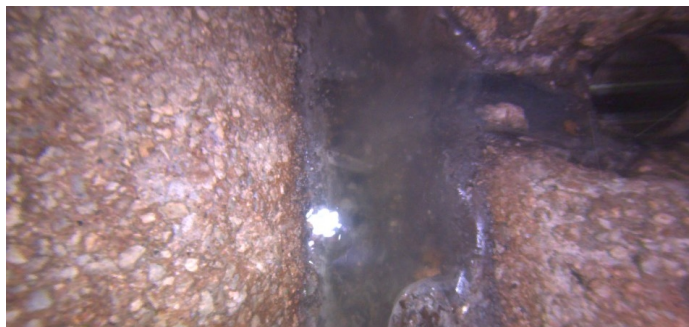
Code: **MGP**  
Description: **General Photo**

Distance (ft): **2.2**  
Structural Grade: **0**  
O&M Grade: **0**  
Clock Start/From:  
Clock To:  
1st Value:  
2nd Value:  
Value Percent:  
Step: **NO**  
Remarks:
