Manhole Inspection Report

Date:	04/04/2018	Weather:		Coding:	RZMACP
MH#:	M-607-038	Owner:	NA	Len. Surveyed:	6.1
P.O.#:		Surveyor:	John Kuglmaier	Rim to Invert:	6.6
Customer:		Cert. #:	U-1215-07002349	Wall Material:	Concrete (reinforced)

Street:	Medlee Dr. 178' North of Diane Ct.	Project:	Hobart, IN
City:	Hobart, IN	GPS Northing:	0.0
Location:		GPS Easting:	0.0
Drain Area:	Southwest	GPS Accuracy:	Nearest Meter
Cover Shape:	Circular	Evidence of Surcharge:	No
Cover Size:	22.5	Potential for Runoff:	None
Comments:

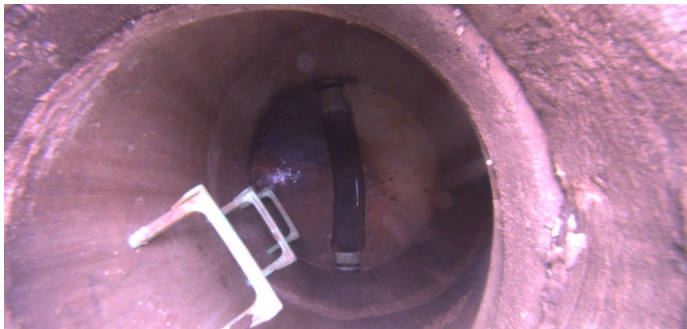
Code:	MGP
Description:	General Photo

Distance (ft):	.0
Structural Grade:	0
O&M Grade:	0
Clock Start/From:	
Clock To:	
1st Value:	
2nd Value:	
Value Percent:	
Step:	NO
Remarks:

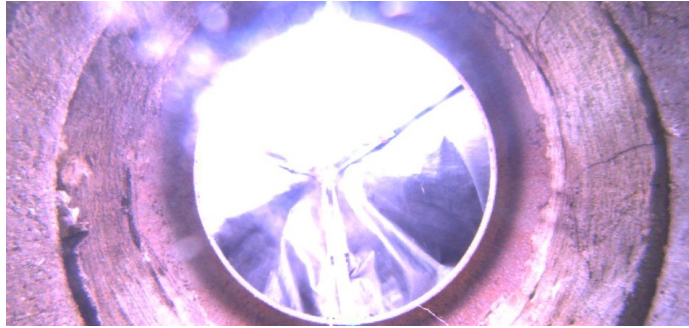
Code:	MGP
Description:	General Photo
Distance (ft):	2.1
Structural Grade:	0
O&M Grade:	0
Clock Start/From:	
Clock To:	
1st Value:	
2nd Value:	
Value Percent:	
Step:	NO
Remarks:

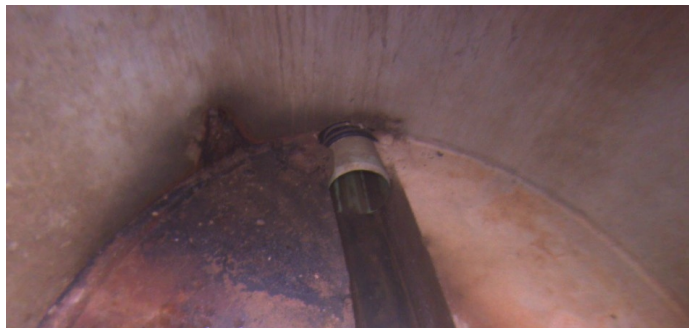
Code:	IS
Description:	Infil Stain
Distance (ft):	4.3
Structural Grade:	0
O&M Grade:	0
Clock Start/From:	11
Clock To:	
1st Value:	
2nd Value:	
Value Percent:	
Step:	NO
Remarks:

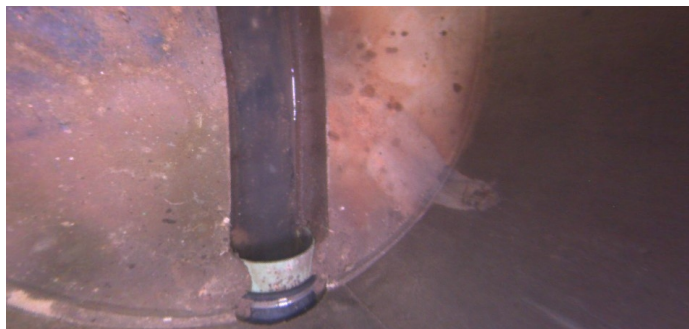
Code:	IS
Description:	Infil Stain
Distance (ft):	4.3
Structural Grade:	0
O&M Grade:	0
Clock Start/From:	4
Clock To:	
1st Value:	
2nd Value:	
Value Percent:	
Step:	NO
Remarks:

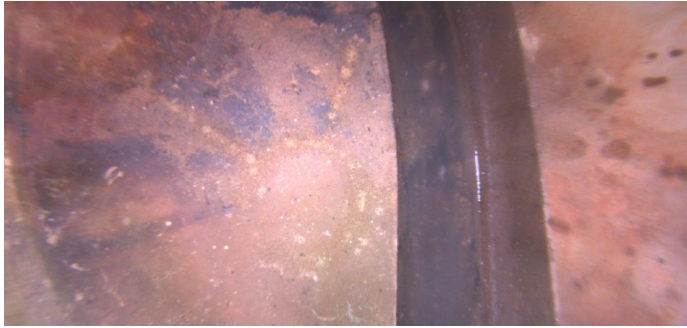
Code:	MGO
Description:	General Observation
Distance (ft):	5.0
Structural Grade:	0
O&M Grade:	0
Clock Start/From:	
Clock To:	
1st Value:	
2nd Value:	
Value Percent:	
Step:	NO
Remarks:	Ins. Comp.
