Manhole Inspection Report

Date:	04/04/2018	Weather:		Coding:	RZMACP
MH#:	M-607-040	Owner:	NA	Len. Surveyed:	4.2
P.O.#:		Surveyor:	John Kuglmaier	Rim to Invert:	4.8
Customer:		Cert. #:	U-1215-07002349	Wall Material:	Concrete (reinforced)

Street:	Medlee Ct and Medlee Dr. to the So	Project:	Hobart, IN
City:	Hobart, IN	GPS Northing:	0.0
Location:		GPS Easting:	0.0
Drain Area:	Southwest	GPS Accuracy:	Nearest Meter
Cover Shape:	Circular	Evidence of Surcharge:	No
Cover Size:	22.5	Potential for Runoff:	None
Comments:

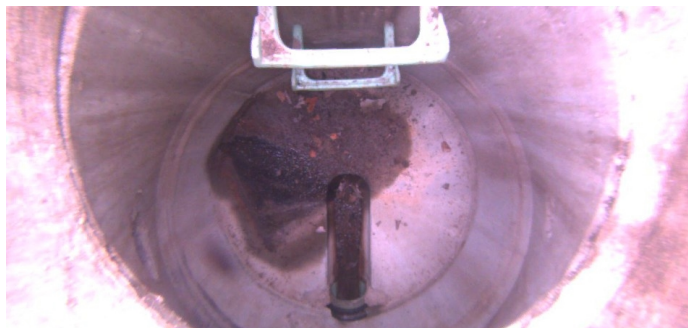
Code: **MGP**
Description: **General Photo**

Distance (ft): **.0**
Structural Grade: **0**
O&M Grade: **0**
Clock Start/From:
Clock To:
1st Value:
2nd Value:
Value Percent:
Step: **NO**
Remarks:

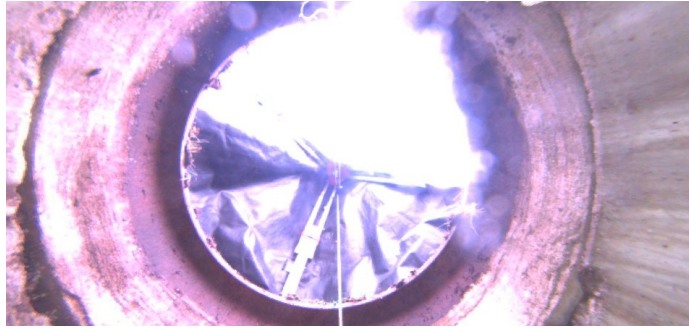
Code: **MGP**
Description: **General Photo**

Distance (ft): **2.3**
Structural Grade: **0**
O&M Grade: **0**
Clock Start/From:
Clock To:
1st Value:
2nd Value:
Value Percent:
Step: **NO**
Remarks:

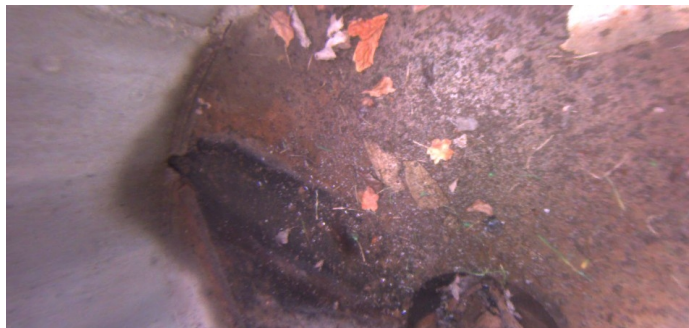
Code: **IS**
Description: **Infil Stain**

Distance (ft): **3.1**
Structural Grade: **0**
O&M Grade: **0**
Clock Start/From: **10**
Clock To:
1st Value:
2nd Value:
Value Percent:
Step: **NO**
Remarks:

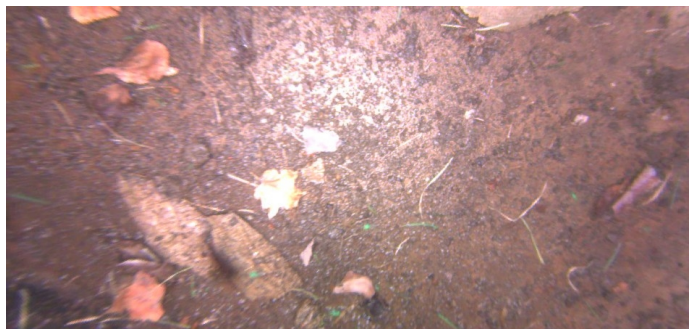
Code: **MGO**
Description: **General Observation**

Distance (ft): **3.8**
Structural Grade: **0**
O&M Grade: **0**
Clock Start/From:
Clock To:
1st Value:
2nd Value:
Value Percent:
Step: **NO**
Remarks: **Ins. Comp.**
