Manhole Inspection Report

Date:	04/04/2018	Weather:		Coding:	RZMACP
MH#:	M-607-048	Owner:	NA	Len. Surveyed:	9.3
P.O.#:		Surveyor:	John Kuglmaier	Rim to Invert:	9.6
Customer:		Cert. #:	U-1215-07002349	Wall Material:	Concrete (reinforced)

Street:	Medlee Dr. 316' North of Fatima Ln.	Project:	Hobart, IN
City:	Hobart, IN	GPS Northing:	0.0
Location:		GPS Easting:	0.0
Drain Area:	Southwest	GPS Accuracy:	Nearest Meter
Cover Shape:	Circular	Evidence of Surcharge:	No
Cover Size:	22.5	Potential for Runoff:	None
Comments:

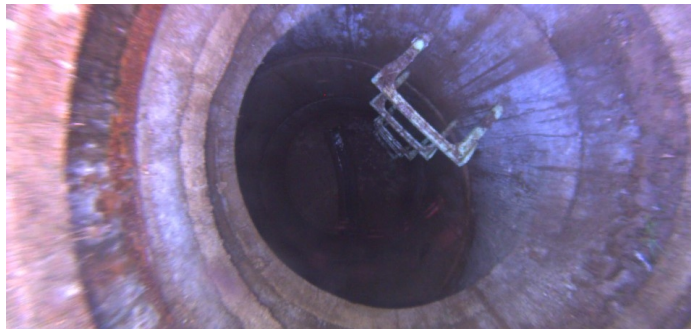
Code: **MGP**
Description: **General Photo**

Distance (ft): **.0**
Structural Grade: **0**
O&M Grade: **0**
Clock Start/From:
Clock To:
1st Value:
2nd Value:
Value Percent:
Step: **NO**
Remarks:

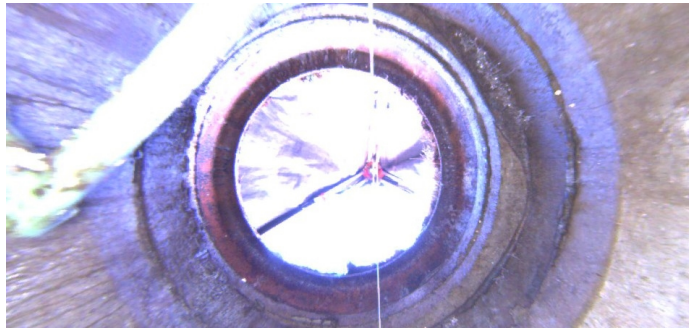
Code:	MGP
Description:	General Photo
Distance (ft):	3.1
Structural Grade:	0
O&M Grade:	0
Clock Start/From:	
Clock To:	
1st Value:	
2nd Value:	
Value Percent:	
Step:	NO
Remarks:

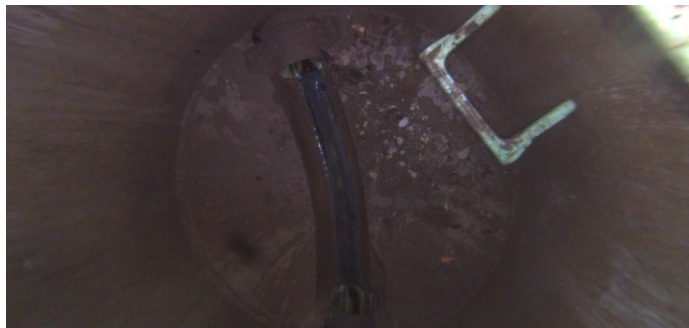
Code:	DSF
Description:	Deposits Settled Fine
Distance (ft):	6.1
Structural Grade:	0
O&M Grade:	2
Clock Start/From:	11
Clock To:	4
1st Value:	
2nd Value:	
Value Percent:	5.000
Step:	NO
Remarks:

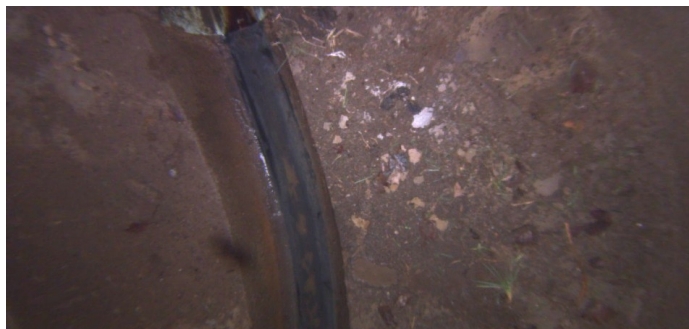
Code:	MGO
Description:	General Observation
Distance (ft):	7.9
Structural Grade:	0
O&M Grade:	0
Clock Start/From:	
Clock To:	
1st Value:	
2nd Value:	
Value Percent:	
Step:	NO
Remarks:	Ins. Comp.
