Date:	04/04/2018	Weather:		Coding:	RZMACP
MH#:	M-607-050	Owner:	NA	Len. Surveyed:	9.6
P.O.#:		Surveyor:	John Kuglmaier	Rim to Invert:	10.6
Customer:		Cert. #:	U-1215-07002349	Wall Material:	Concrete (reinforced)
Street:	Medlee Dr. 4th Ma	nhole South of N	Project:	Hobart, IN	
City:	Hobart, IN	(GPS Northing:	0.0	
Location:		(GPS Easting:	0.0	
Drain Area:	Southwest	(GPS Accuracy:	Nearest Meter	
Cover Shape:	Circular	I	Evidence of Surcharge:	No	
Cover Size: Comments:	22.5	I	Potential for Runoff:	None	
O&M Index:	2.50	O&M Quick:	3121	O&M Rating:	5.00
Structural Index:	0.00	Structural Quid	ck: 0000	Structural Rating:	0.00
Overall Index:	2.50	Overall Quick:	3121	Overall Rating:	5.00

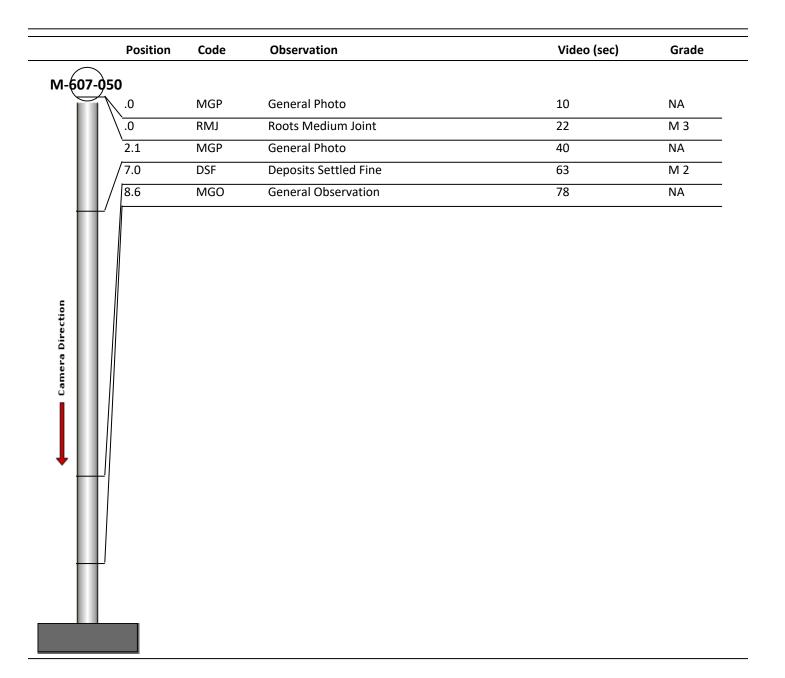
Code:	MGP
Description:	General Photo
Distance (ft):	.0
Structural Grade:	0
O&M Grade:	0
Clock Start/From:	
Clock To:	
1st Value:	
2nd Value:	
Value Percent:	
Step:	NO
Remarks:
