Manhole Inspection Report

Date:	04/25/2018	Weather:		Coding:	RZMACP
MH#:	M-607-051	Owner:	NA	Len. Surveyed:	10.3
P.O.#:		Surveyor:	John Kuglmaier	Rim to Invert:	10.3
Customer:	8.7	Cert. #:	U-1215-07002349	Wall Material:	Concrete (reinforced)

Street:	Medlee Dr. 3rd Manhole South of N	Project:	Hobart, IN
City:	Hobart, IN	GPS Northing:	0.0
Location:		GPS Easting:	0.0
Drain Area:	Southwest	GPS Accuracy:	Nearest Meter
Cover Shape:	Circular	Evidence of Surcharge:	No
Cover Size:	22.5	Potential for Runoff:	None
Comments:

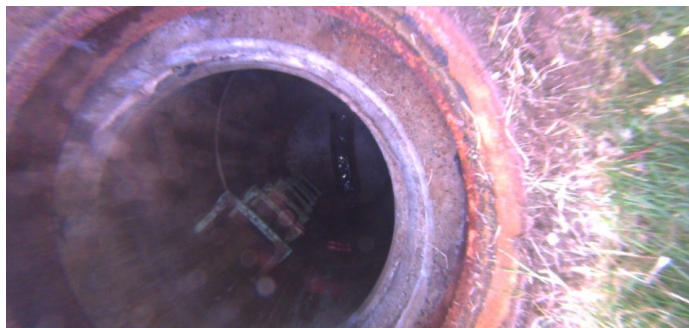
Code: **MGP**
Description: **General Photo**

Distance (ft): **.0**
Structural Grade: **0**
O&M Grade: **0**
Clock Start/From:
Clock To:
1st Value:
2nd Value:
Value Percent:
Step: **NO**
Remarks:

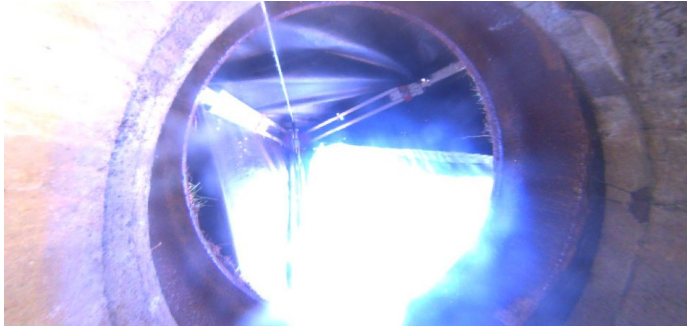
Code: **MGP**
Description: **General Photo**

Distance (ft): **2.9**
Structural Grade: **0**
O&M Grade: **0**
Clock Start/From:
Clock To:
1st Value:
2nd Value:
Value Percent:
Step: **NO**
Remarks:

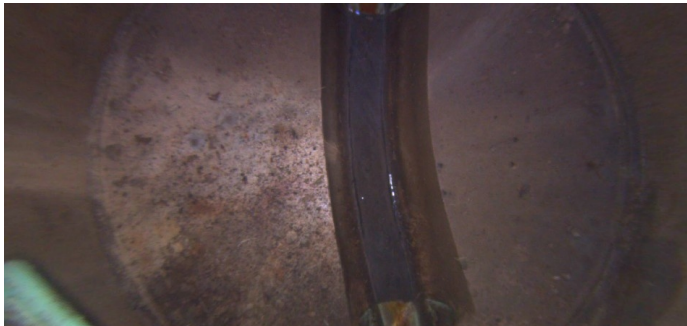
Code: **MGO**
Description: **General Observation**

Distance (ft): **8.7**
Structural Grade: **0**
O&M Grade: **0**
Clock Start/From:
Clock To:
1st Value:
2nd Value:
Value Percent:
Step: **NO**
Remarks: **Ins. Comp.**
