Manhole Inspection Report

Date:	04/25/2018	Weather:		Coding:	RZMACP
MH#:	M-607-052	Owner:	NA	Len. Surveyed:	9.9
P.O.#:		Surveyor:	John Kuglmaier	Rim to Invert:	10.1
Customer:	8.7	Cert. #:	U-1215-07002349	Wall Material:	Concrete (reinforced)

Street:	Medlee Dr. 2nd Manhole South of N	Project:	Hobart, IN
City:	Hobart, IN	GPS Northing:	0.0
Location:		GPS Easting:	0.0
Drain Area:	Southwest	GPS Accuracy:	Nearest Meter
Cover Shape:	Circular	Evidence of Surcharge:	No
Cover Size:	22.5	Potential for Runoff:	None
Comments:

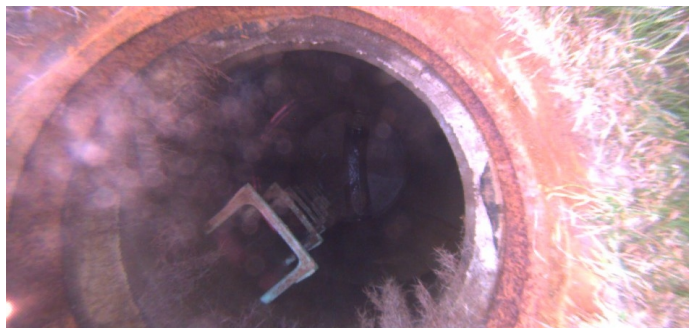
Code: **MGP**
Description: **General Photo**

Distance (ft): **.0**
Structural Grade: **0**
O&M Grade: **0**
Clock Start/From:
Clock To:
1st Value:
2nd Value:
Value Percent:
Step: **NO**
Remarks:

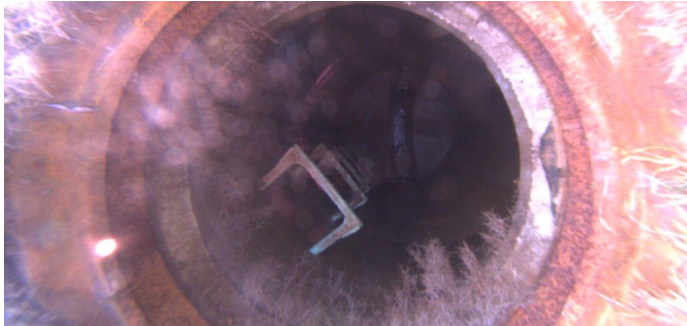
Code: **RFJ**
Description: **Roots Fine Joint**

Distance (ft): **.0**
Structural Grade: **0**
O&M Grade: **1**
Clock Start/From: **4**
Clock To: **11**
1st Value:
2nd Value:
Value Percent:
Step: **NO**
Remarks:

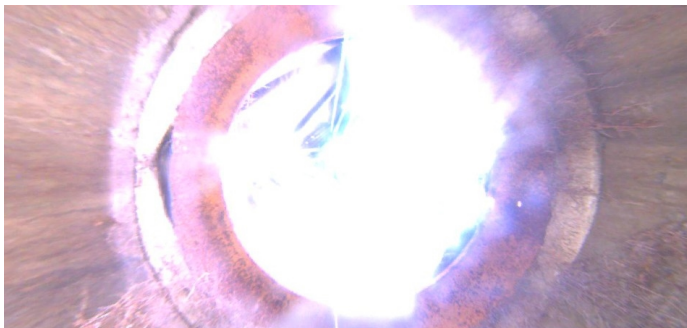
Code: **MGP**
Description: **General Photo**

Distance (ft): **3.1**
Structural Grade: **0**
O&M Grade: **0**
Clock Start/From:
Clock To:
1st Value:
2nd Value:
Value Percent:
Step: **NO**
Remarks:

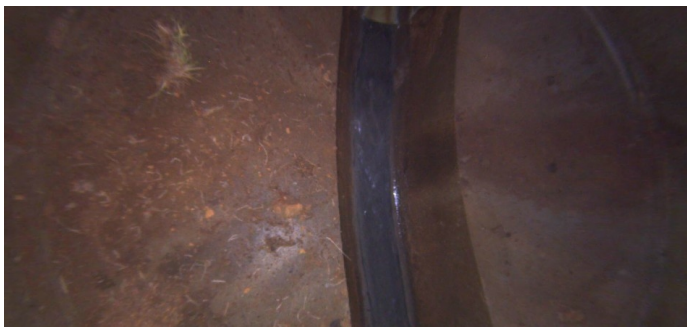
Code: **MGO**
Description: **General Observation**

Distance (ft): **8.8**
Structural Grade: **0**
O&M Grade: **0**
Clock Start/From:
Clock To:
1st Value:
2nd Value:
Value Percent:
Step: **NO**
Remarks: **Ins. Comp.**
