Manhole Inspection Report

Date:	04/04/2018	Weather:		Coding:	RZMACP
MH#:	M-607-055	Owner:	NA	Len. Surveyed:	6.1
P.O.#:		Surveyor:	John Kuglmaier	Rim to Invert:	6.3
Customer:		Cert. #:	U-1215-07002349	Wall Material:	Concrete (reinforced)

Street:	Wisconsin St. 385' North of 14th St.	Project:	Hobart, IN
City:	Hobart, IN	GPS Northing:	0.0
Location:		GPS Easting:	0.0
Drain Area:	Southwest	GPS Accuracy:	Nearest Meter
Cover Shape:	Circular	Evidence of Surcharge:	No
Cover Size:	22.5	Potential for Runoff:	None
Comments:

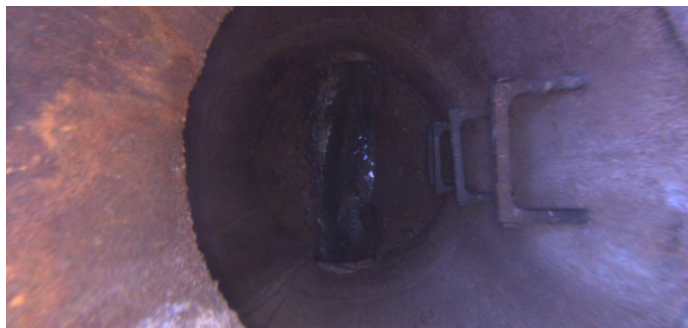
Code: **MGP**
Description: **General Photo**

Distance (ft): **.0**
Structural Grade: **0**
O&M Grade: **0**
Clock Start/From:
Clock To:
1st Value:
2nd Value:
Value Percent:
Step: **NO**
Remarks:

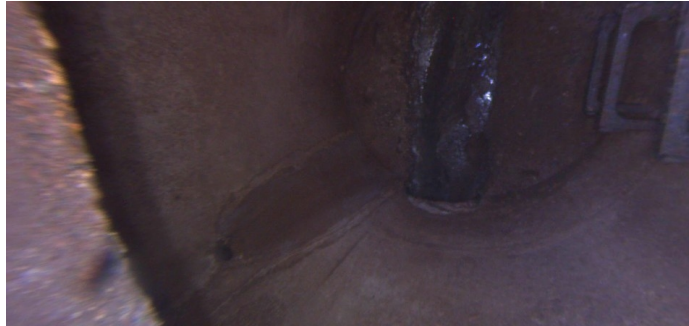
Code: **IS**
Description: **Infil Stain**

Distance (ft): **1.0**
Structural Grade: **0**
O&M Grade: **0**
Clock Start/From: **7**
Clock To:
1st Value:
2nd Value:
Value Percent:
Step: **NO**
Remarks:

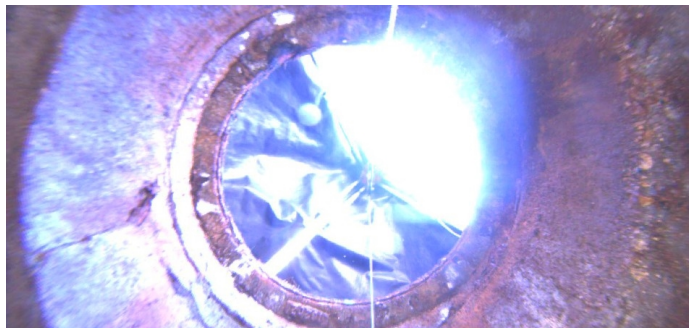
Code: **MGP**
Description: **General Photo**

Distance (ft): **2.4**
Structural Grade: **0**
O&M Grade: **0**
Clock Start/From:
Clock To:
1st Value:
2nd Value:
Value Percent:
Step: **NO**
Remarks:

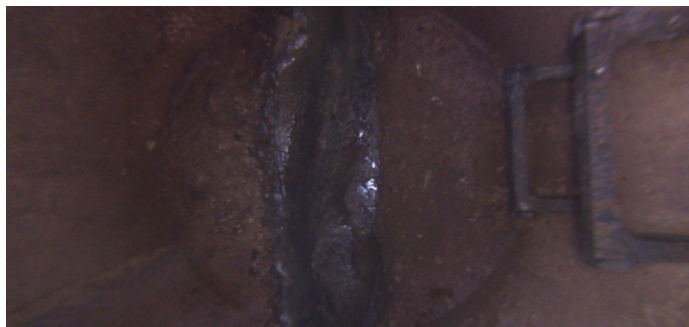
Code: **DAZ**
Description: **Deposits Attached Other**

Distance (ft): **3.0**
Structural Grade: **0**
O&M Grade: **2**
Clock Start/From: **12**
Clock To: **12**
1st Value:
2nd Value:
Value Percent: **10.000**
Step: **NO**
Remarks: **Mixed materials**

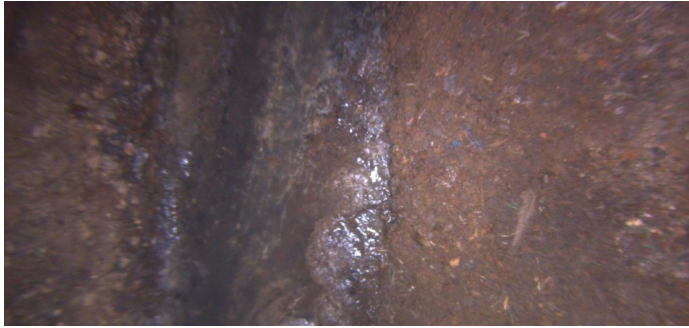
Code:	MGO
Description:	General Observation
Distance (ft):	5.1
Structural Grade:	0
O&M Grade:	0
Clock Start/From:	
Clock To:	
1st Value:	
2nd Value:	
Value Percent:	
Step:	NO
Remarks:	Ins. Comp.
