Manhole Inspection Report

Date:	04/04/2018	Weather:		Coding:	RZMACP
MH#:	M-607-057	Owner:	NA	Len. Surveyed:	7.1
P.O.#:		Surveyor:	John Kuglmaier	Rim to Invert:	7.3
Customer:		Cert. #:	U-1215-07002349	Wall Material:	Concrete (reinforced)

Street:	Fatima Ln. and Wisconsin St.	Project:	Hobart, IN
City:	Hobart, IN	GPS Northing:	0.0
Location:		GPS Easting:	0.0
Drain Area:	Southwest	GPS Accuracy:	Nearest Meter
Cover Shape:	Circular	Evidence of Surcharge:	No
Cover Size:	22.5	Potential for Runoff:	None
Comments:

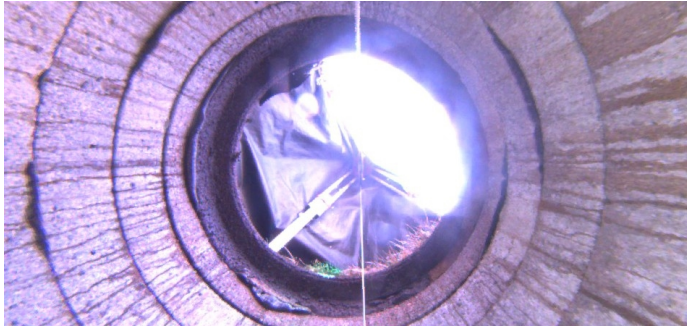
Code:	MGP
Description:	General Photo

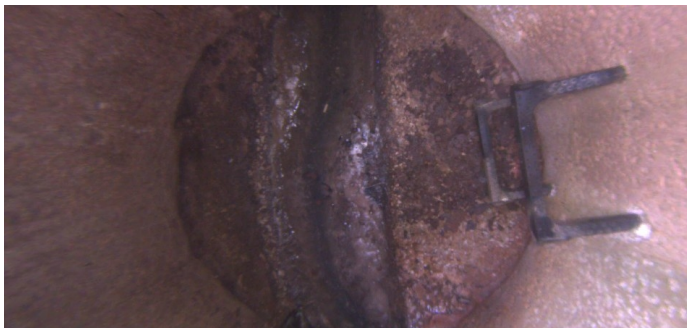
Code: **MGP**
Description: **General Photo**

Distance (ft): **2.9**
Structural Grade: **0**
O&M Grade: **0**
Clock Start/From:
Clock To:
1st Value:
2nd Value:
Value Percent:
Step: **NO**
Remarks:

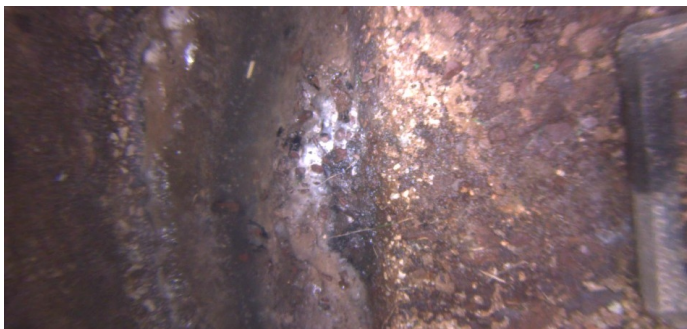
Code: **DAZ**
Description: **Deposits Attached Other**

Distance (ft): **4.4**
Structural Grade: **0**
O&M Grade: **2**
Clock Start/From: **12**
Clock To: **12**
1st Value:
2nd Value:
Value Percent: **5.000**
Step: **NO**
Remarks: **Mixed materials**
