Manhole Inspection Report

Date:	03/28/2018	Weather:		Coding:	RZMACP
MH#:	M-607-058	Owner:	NA	Len. Surveyed:	4.1
P.O.#:		Surveyor:	John Kuglmaier	Rim to Invert:	5.0
Customer:		Cert. #:	U-1215-07002349	Wall Material:	Concrete (reinforced)

Street:	Wisconsin St. 132' North of Morning	Project:	Hobart, IN
City:	Hobart, IN	GPS Northing:	0.0
Location:		GPS Easting:	0.0
Drain Area:	Southwest	GPS Accuracy:	Nearest Meter
Cover Shape:	Circular	Evidence of Surcharge:	No
Cover Size:	22.5	Potential for Runoff:	None
Comments:

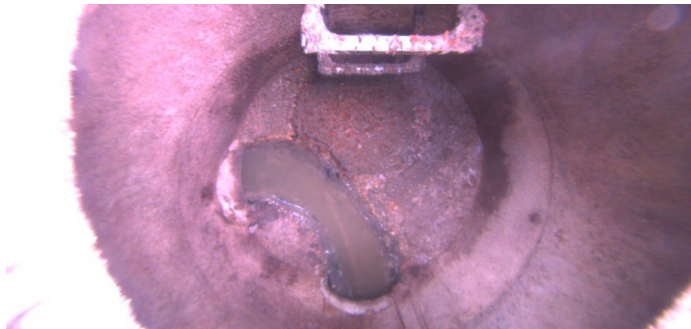
Code: **MGP**
Description: **General Photo**

Distance (ft): **.0**
Structural Grade: **0**
O&M Grade: **0**
Clock Start/From:
Clock To:
1st Value:
2nd Value:
Value Percent:
Step: **NO**
Remarks:

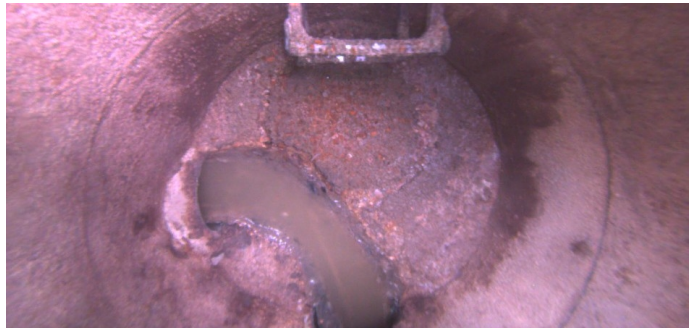
Code: **DSF**
Description: **Deposits Settled Fine**

Distance (ft): **1.1**
Structural Grade: **0**
O&M Grade: **2**
Clock Start/From: **12**
Clock To: **12**
1st Value:
2nd Value:
Value Percent: **5.000**
Step: **NO**
Remarks:

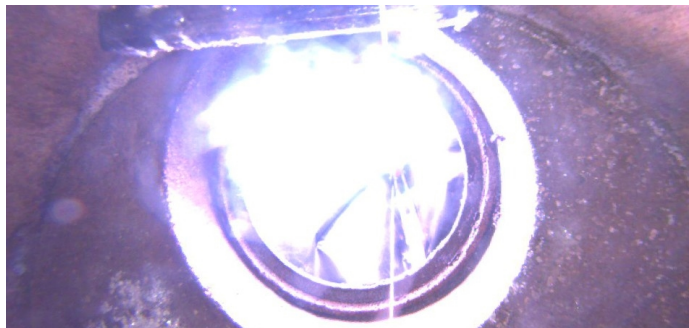
Code: **MGP**
Description: **General Photo**

Distance (ft): **2.5**
Structural Grade: **0**
O&M Grade: **0**
Clock Start/From:
Clock To:
1st Value:
2nd Value:
Value Percent:
Step: **NO**
Remarks:

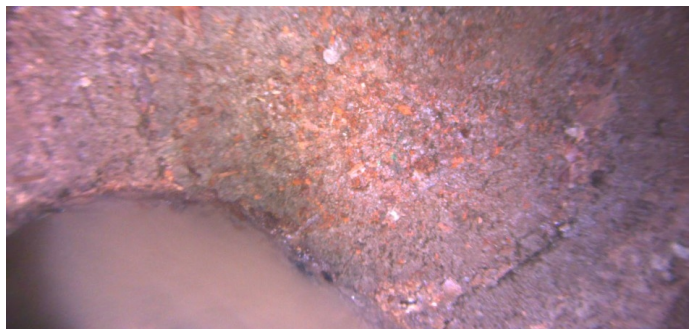
Code: **MGO**
Description: **General Observation**

Distance (ft): **3.3**
Structural Grade: **0**
O&M Grade: **0**
Clock Start/From:
Clock To:
1st Value:
2nd Value:
Value Percent:
Step: **NO**
Remarks: **Ins. Comp.**
