Manhole Inspection Report

Date:	03/28/2018	Weather:		Coding:	RZMACP
MH#:	M-607-059	Owner:	NA	Len. Surveyed:	4.1
P.O.#:		Surveyor:	John Kuglmaier	Rim to Invert:	4.5
Customer:		Cert. #:	U-1215-07002349	Wall Material:	Concrete (reinforced)

Street:	Wisconsin St. 130' North of Morning	Project:	Hobart, IN
City:	Hobart, IN	GPS Northing:	0.0
Location:		GPS Easting:	0.0
Drain Area:	Southwest	GPS Accuracy:	Nearest Meter
Cover Shape:	Circular	Evidence of Surcharge:	Yes
Cover Size:	22.5	Potential for Runoff:	None
Comments:

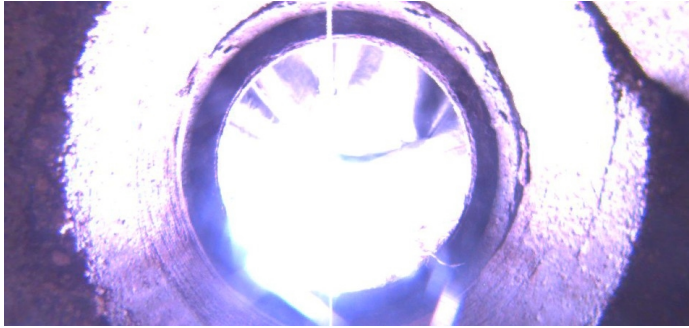
Code:	MGP
Description:	General Photo

Distance (ft):	.0
Structural Grade:	0
O&M Grade:	0
Clock Start/From:	
Clock To:	
1st Value:	
2nd Value:	
Value Percent:	
Step:	NO
Remarks:

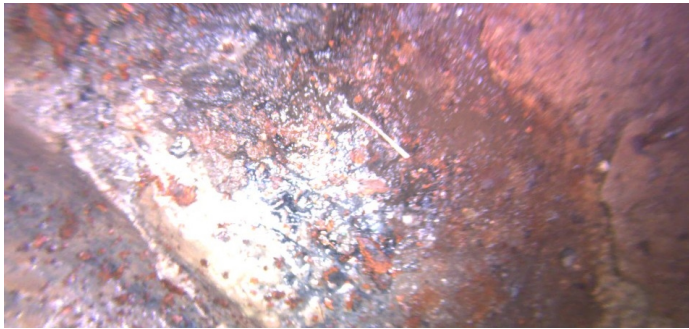
Code: **MGP**
Description: **General Photo**

Distance (ft): **2.5**
Structural Grade: **0**
O&M Grade: **0**
Clock Start/From:
Clock To:
1st Value:
2nd Value:
Value Percent:
Step: **NO**
Remarks:
