Manhole Inspection Report

Date:	04/05/2018	Weather:		Coding:	RZMACP
MH#:	M-607-060	Owner:	NA	Len. Surveyed:	10.2
P.O.#:		Surveyor:	John Kuglmaier	Rim to Invert:	10.3
Customer:		Cert. #:	U-1215-07002349	Wall Material:	Concrete (reinforced)

Street:	14th St. 361' East of Washington St.	Project:	Hobart, IN
City:	Hobart, IN	GPS Northing:	0.0
Location:		GPS Easting:	0.0
Drain Area:	Southwest	GPS Accuracy:	Nearest Meter
Cover Shape:	Circular	Evidence of Surcharge:	No
Cover Size:	22.5	Potential for Runoff:	None
Comments:

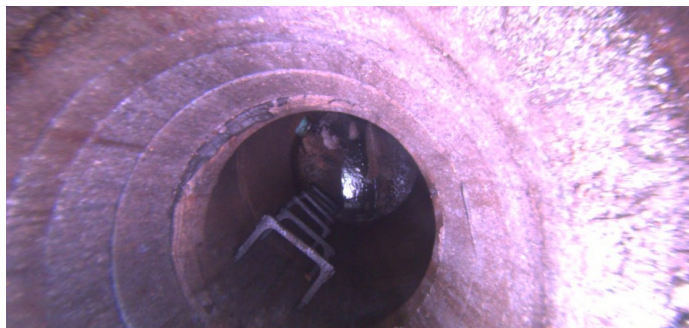
Code: **MGP**
Description: **General Photo**

Distance (ft): **.0**
Structural Grade: **0**
O&M Grade: **0**
Clock Start/From:
Clock To:
1st Value:
2nd Value:
Value Percent:
Step: **NO**
Remarks:

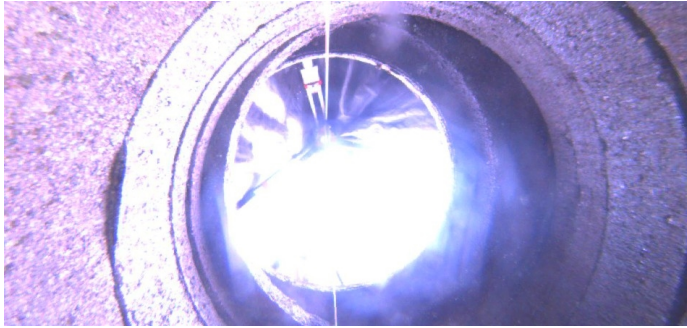
Code:	MGP
Description:	General Photo
Distance (ft):	2.7
Structural Grade:	0
O&M Grade:	0
Clock Start/From:	
Clock To:	
1st Value:	
2nd Value:	
Value Percent:	
Step:	NO
Remarks:

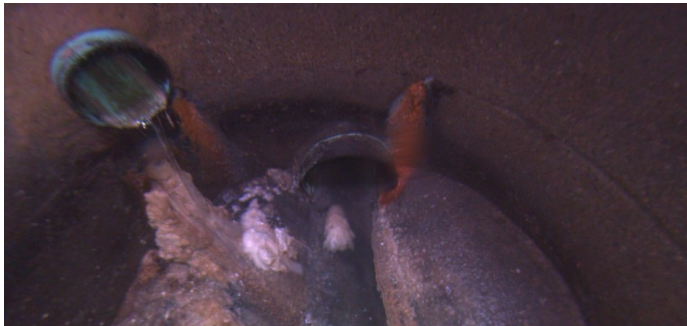
Code:	IS
Description:	Infil Stain
Distance (ft):	6.9
Structural Grade:	0
O&M Grade:	0
Clock Start/From:	11
Clock To:	
1st Value:	
2nd Value:	
Value Percent:	
Step:	NO
Remarks:

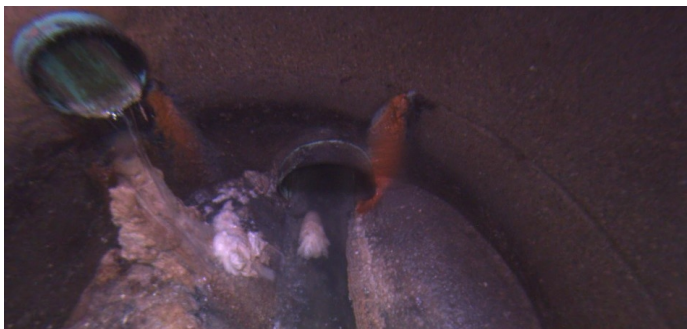
Code:	IS
Description:	Infil Stain
Distance (ft):	6.9
Structural Grade:	0
O&M Grade:	0
Clock Start/From:	1
Clock To:	
1st Value:	
2nd Value:	
Value Percent:	
Step:	NO
Remarks:

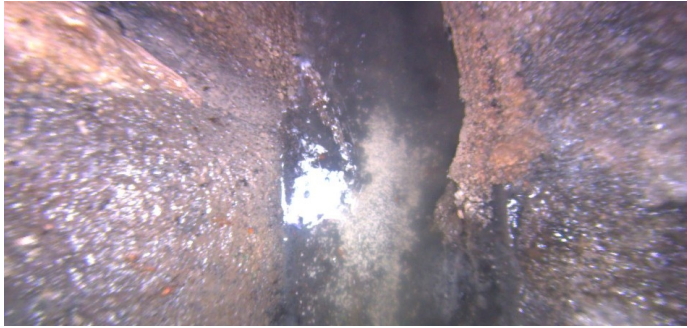
Code:	MGO
Description:	General Observation
Distance (ft):	9.0
Structural Grade:	0
O&M Grade:	0
Clock Start/From:	
Clock To:	
1st Value:	
2nd Value:	
Value Percent:	
Step:	NO
Remarks:	Ins. Comp.
