Manhole Inspection Report

Date:	04/06/2018	Weather:		Coding:	RZMACP
MH#:	M-607-064	Owner:	NA	Len. Surveyed:	12.7
P.O.#:		Surveyor:	John Kuglmaier	Rim to Invert:	13.4
Customer:		Cert. #:	U-1215-07002349	Wall Material:	Concrete (reinforced)

Street:	14th St. 379' East of West 61st St.	Project:	Hobart, IN
City:	Hobart, IN	GPS Northing:	0.0
Location:		GPS Easting:	0.0
Drain Area:	Southwest	GPS Accuracy:	Nearest Meter
Cover Shape:	Circular	Evidence of Surcharge:	Yes
Cover Size:	22.5	Potential for Runoff:	None
Comments:

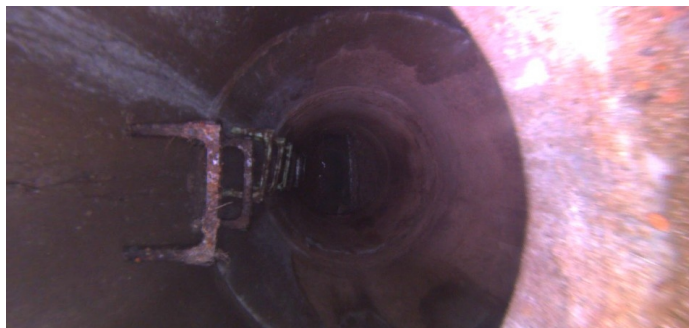
Code: **MGP**
 Description: **General Photo**

Distance (ft): **.0**
 Structural Grade: **0**
 O&M Grade: **0**
 Clock Start/From:
 Clock To:
 1st Value:
 2nd Value:
 Value Percent:
 Step: **NO**
 Remarks:

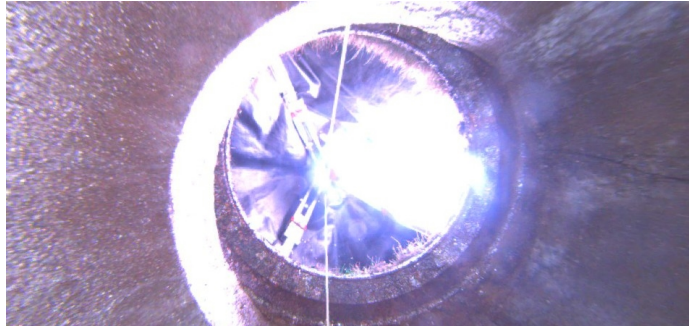
Code: **MGP**
Description: **General Photo**

Distance (ft): **2.5**
Structural Grade: **0**
O&M Grade: **0**
Clock Start/From:
Clock To:
1st Value:
2nd Value:
Value Percent:
Step: **NO**
Remarks:

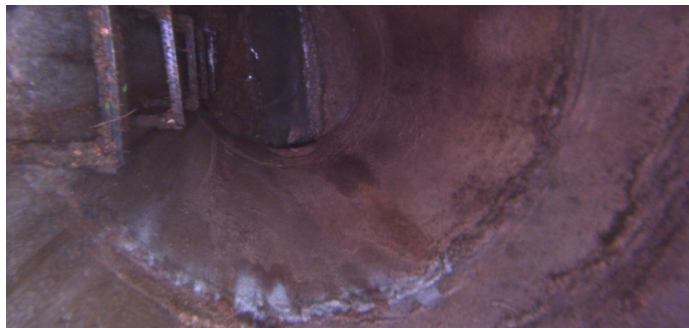
Code: **IS**
Description: **Infil Stain**

Distance (ft): **5.7**
Structural Grade: **0**
O&M Grade: **0**
Clock Start/From: **5**
Clock To:
1st Value:
2nd Value:
Value Percent:
Step: **NO**
Remarks:

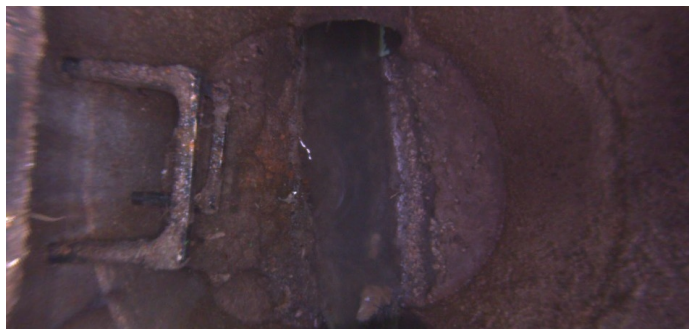
Code: **DSF**
Description: **Deposits Settled Fine**

Distance (ft): **9.9**
Structural Grade: **0**
O&M Grade: **3**
Clock Start/From: **12**
Clock To: **12**
1st Value:
2nd Value:
Value Percent: **15.000**
Step: **NO**
Remarks:

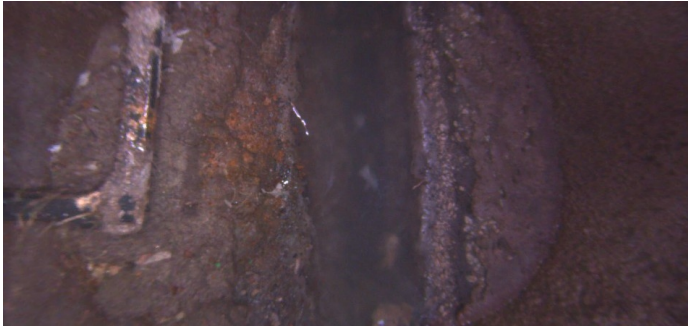
Code:	MGO
Description:	General Observation
Distance (ft):	11.1
Structural Grade:	0
O&M Grade:	0
Clock Start/From:	
Clock To:	
1st Value:	
2nd Value:	
Value Percent:	
Step:	NO
Remarks:	Ins. Comp.
