# Manhole Inspection Report

Date:	<b>04/08/2018</b>	Weather:		Coding:	<b>RZMACP</b>
MH#:	<b>M-607-068</b>	Owner:	<b>NA</b>	Len. Surveyed:	<b>14.7</b>
P.O.#:		Surveyor:	<b>John Kuglmaier</b>	Rim to Invert:	<b>14.7</b>
Customer:		Cert. #:	<b>U-1215-07002349</b>	Wall Material:	<b>Concrete (reinforced)</b>

Street:	<b>14th St. 338' West of Hwy 51.</b>	Project:	<b>Hobart, IN</b>
City:	<b>Hobart, IN</b>	GPS Northing:	<b>2904323.617</b>
Location:		GPS Easting:	<b>2904323.617</b>
Drain Area:	<b>Southwest</b>	GPS Accuracy:	<b>Sub-Meter</b>
Cover Shape:	<b>Circular</b>	Evidence of Surcharge:	<b>Yes</b>
Cover Size:	<b>22.5</b>	Potential for Runoff:	<b>None</b>
Comments:

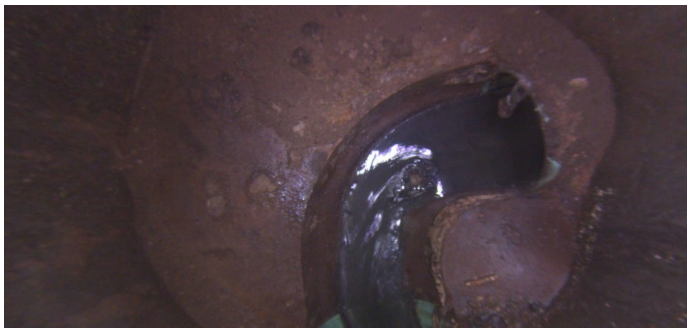
Code: **MGP**  
Description: **General Photo**

Distance (ft): **2.4**  
Structural Grade: **0**  
O&M Grade: **0**  
Clock Start/From:  
Clock To:  
1st Value:  
2nd Value:  
Value Percent:  
Step: **NO**  
Remarks:
