Manhole Inspection Report

Date:	04/04/2018	Weather:		Coding:	RZMACP
MH#:	M-607-069	Owner:	NA	Len. Surveyed:	4.9
P.O.#:		Surveyor:	John Kuglmaier	Rim to Invert:	5.6
Customer:		Cert. #:	U-1215-07002349	Wall Material:	Concrete (reinforced)

Street:	Medlee Dr. 254' North of Diana Ct.	Project:	Hobart, IN
City:	Hobart, IN	GPS Northing:	0.0
Location:		GPS Easting:	0.0
Drain Area:	Southwest	GPS Accuracy:	Nearest Meter
Cover Shape:	Circular	Evidence of Surcharge:	No
Cover Size:	22.5	Potential for Runoff:	None
Comments:

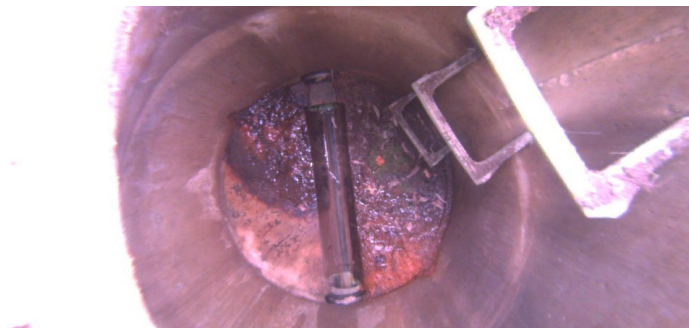
Code: **MGP**
Description: **General Photo**

Distance (ft): **.0**
Structural Grade: **0**
O&M Grade: **0**
Clock Start/From:
Clock To:
1st Value:
2nd Value:
Value Percent:
Step: **NO**
Remarks:

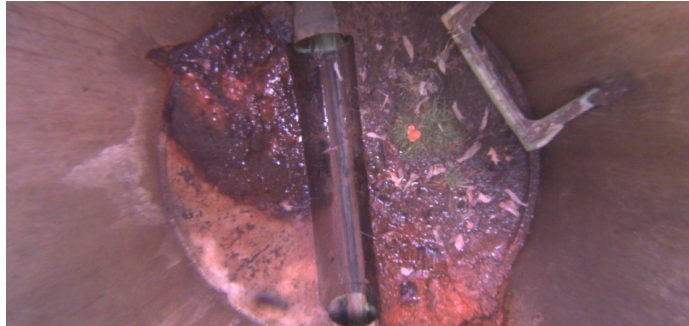
Code:	DAZ
Description:	Deposits Attached Other
Distance (ft):	2.1
Structural Grade:	0
O&M Grade:	2
Clock Start/From:	12
Clock To:	12
1st Value:	
2nd Value:	
Value Percent:	5.000
Step:	NO
Remarks:	Mixed materials

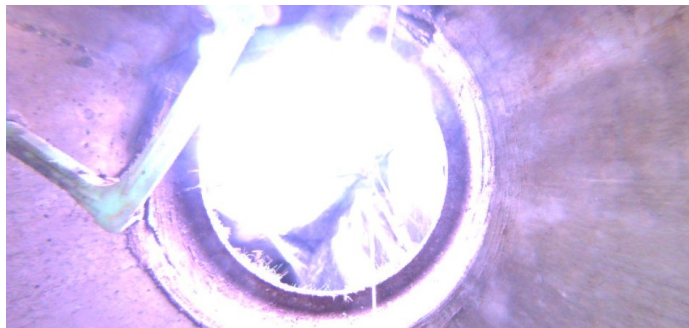
Code:	MGP
Description:	General Photo
Distance (ft):	2.5
Structural Grade:	0
O&M Grade:	0
Clock Start/From:	
Clock To:	
1st Value:	
2nd Value:	
Value Percent:	
Step:	NO
Remarks:

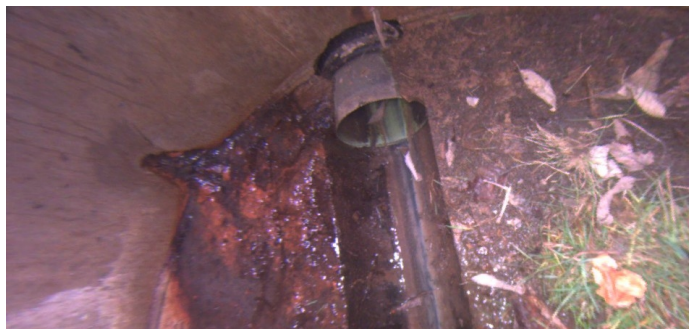
Code:	IS
Description:	Infil Stain
Distance (ft):	3.6
Structural Grade:	0
O&M Grade:	0
Clock Start/From:	11
Clock To:	
1st Value:	
2nd Value:	
Value Percent:	
Step:	NO
Remarks:

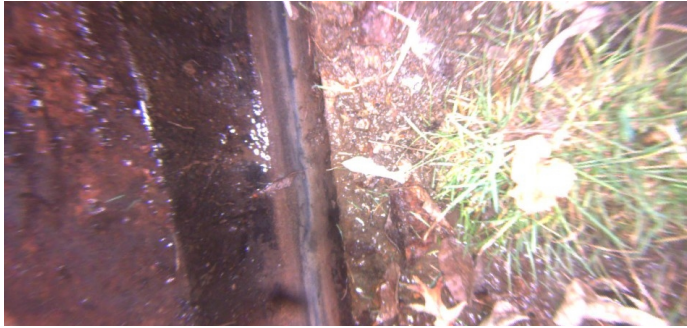
Code:	MGO
Description:	General Observation
Distance (ft):	4.4
Structural Grade:	0
O&M Grade:	0
Clock Start/From:	
Clock To:	
1st Value:	
2nd Value:	
Value Percent:	
Step:	NO
Remarks:	Ins. Comp.
