Manhole Inspection Report

Date:	04/25/2018	Weather:		Coding:	RZMACP
MH#:	M-607-071	Owner:	NA	Len. Surveyed:	8.8
P.O.#:		Surveyor:	John Kuglmaier	Rim to Invert:	9.3
Customer:	8.7	Cert. #:	U-1215-07002349	Wall Material:	Concrete (reinforced)

Street:	10th St. 287' West of Pennsylvania S	Project:	Hobart, IN
City:	Hobart, IN	GPS Northing:	0.0
Location:		GPS Easting:	0.0
Drain Area:	Southwest	GPS Accuracy:	Nearest Meter
Cover Shape:	Circular	Evidence of Surcharge:	Yes
Cover Size:	22.5	Potential for Runoff:	None
Comments:

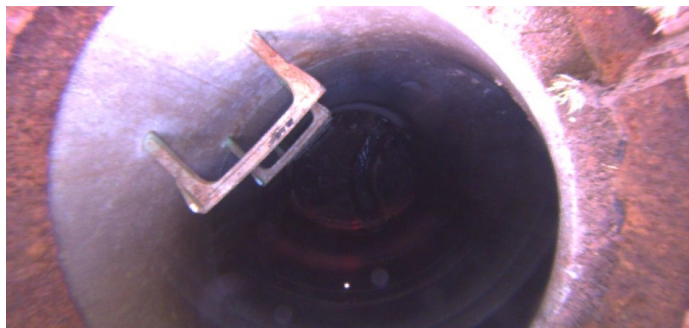
Code: **MGP**
Description: **General Photo**

Distance (ft): **.0**
Structural Grade: **0**
O&M Grade: **0**
Clock Start/From:
Clock To:
1st Value:
2nd Value:
Value Percent:
Step: **NO**
Remarks:

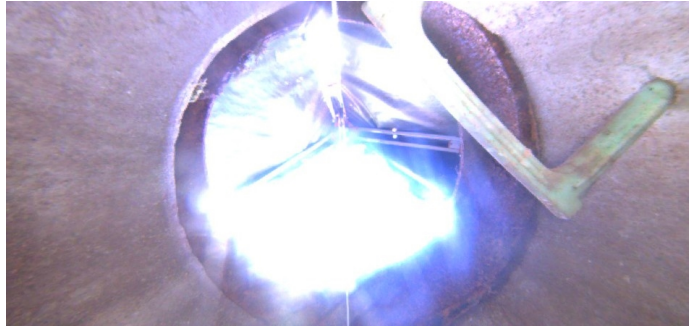
Code: **MGP**
Description: **General Photo**

Distance (ft): **2.9**
Structural Grade: **0**
O&M Grade: **0**
Clock Start/From:
Clock To:
1st Value:
2nd Value:
Value Percent:
Step: **NO**
Remarks:

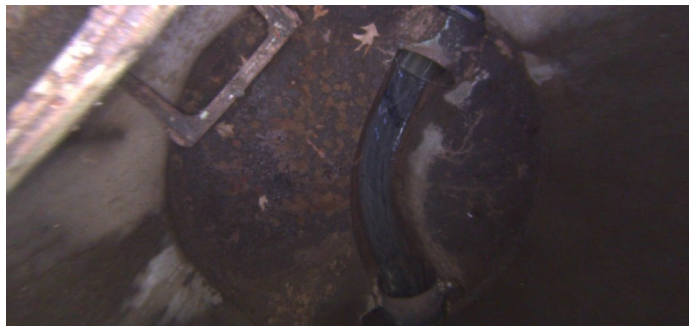
Code: **DSF**
Description: **Deposits Settled Fine**

Distance (ft): **6.6**
Structural Grade: **0**
O&M Grade: **2**
Clock Start/From: **12**
Clock To: **12**
1st Value:
2nd Value:
Value Percent: **5.000**
Step: **NO**
Remarks:

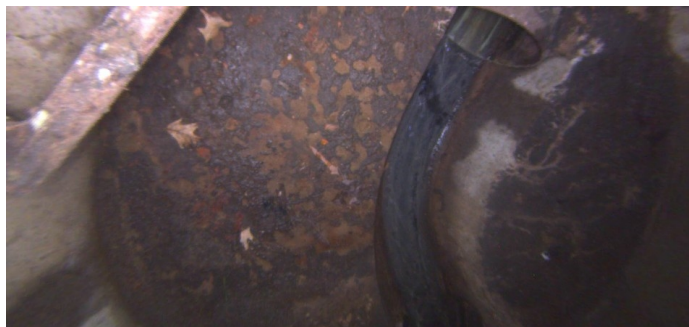
Code: **MGO**
Description: **General Observation**

Distance (ft): **7.6**
Structural Grade: **0**
O&M Grade: **0**
Clock Start/From:
Clock To:
1st Value:
2nd Value:
Value Percent:
Step: **NO**
Remarks: **Ins. Comp.**
