Manhole Inspection Report

Date:	04/05/2018	Weather:		Coding:	RZMACP
MH#:	M-607-072	Owner:	NA	Len. Surveyed:	5.7
P.O.#:		Surveyor:	John Kuglmaier	Rim to Invert:	6.7
Customer:		Cert. #:	U-1215-07002349	Wall Material:	Concrete (reinforced)

Street:	On Ash St. 384' North of 14th St.	Project:	Hobart, IN
City:	Hobart, IN	GPS Northing:	0.0
Location:		GPS Easting:	0.0
Drain Area:	Southwest	GPS Accuracy:	Nearest Meter
Cover Shape:	Circular	Evidence of Surcharge:	No
Cover Size:	22.5	Potential for Runoff:	None
Comments:

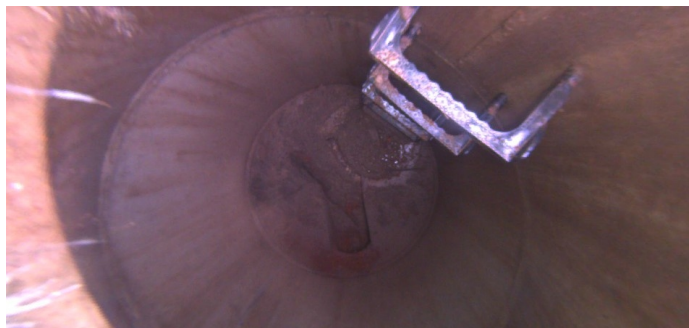
Code: **MGP**
Description: **General Photo**

Distance (ft): **.0**
Structural Grade: **0**
O&M Grade: **0**
Clock Start/From:
Clock To:
1st Value:
2nd Value:
Value Percent:
Step: **NO**
Remarks:

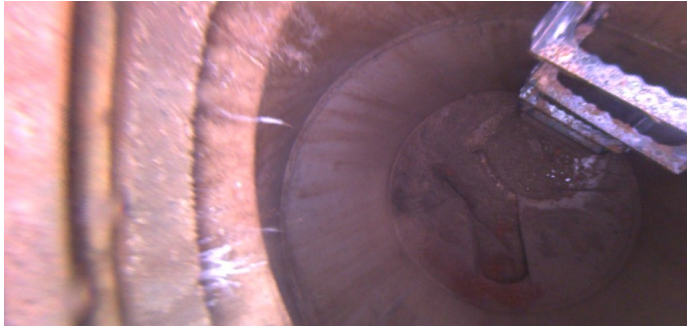
Code:	RFJ
Description:	Roots Fine Joint
Distance (ft):	.0
Structural Grade:	0
O&M Grade:	1
Clock Start/From:	8
Clock To:	11
1st Value:	
2nd Value:	
Value Percent:	
Step:	NO
Remarks:

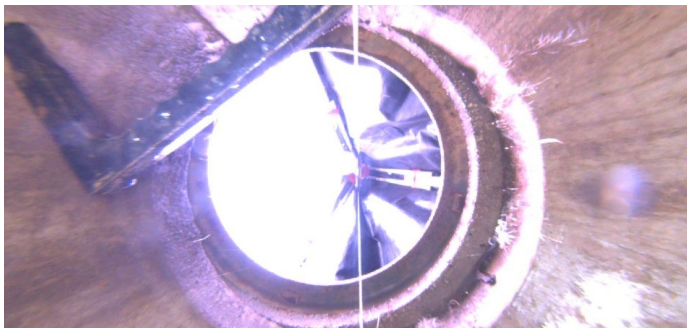
Code:	MGP
Description:	General Photo
Distance (ft):	2.4
Structural Grade:	0
O&M Grade:	0
Clock Start/From:	
Clock To:	
1st Value:	
2nd Value:	
Value Percent:	
Step:	NO
Remarks:

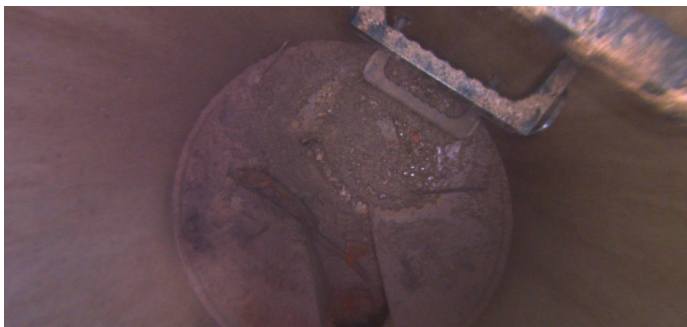
Code:	DSF
Description:	Deposits Settled Fine
Distance (ft):	2.8
Structural Grade:	0
O&M Grade:	2
Clock Start/From:	11
Clock To:	3
1st Value:	
2nd Value:	
Value Percent:	5.000
Step:	NO
Remarks:

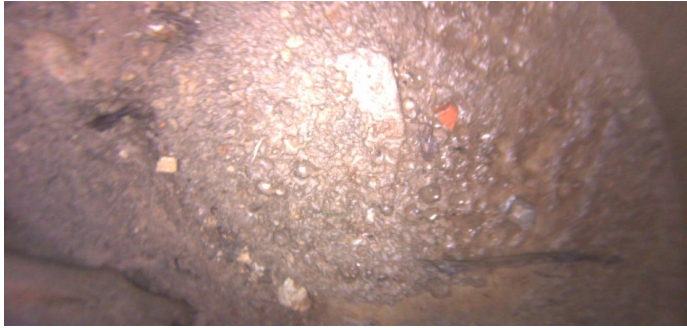
Code:	MGO
Description:	General Observation
Distance (ft):	5.0
Structural Grade:	0
O&M Grade:	0
Clock Start/From:	
Clock To:	
1st Value:	
2nd Value:	
Value Percent:	
Step:	NO
Remarks:	Ins. Comp.
