Manhole Inspection Report

Date:	04/06/2018	Weather:		Coding:	RZMACP
MH#:	M-607-073	Owner:	NA	Len. Surveyed:	4.3
P.O.#:		Surveyor:	John Kuglmaier	Rim to Invert:	5.9
Customer:		Cert. #:	U-1215-07002349	Wall Material:	Concrete (reinforced)

Street:	290' West of Ash St. 209' North of 1	Project:	Hobart, IN
City:	Hobart, IN	GPS Northing:	0.0
Location:		GPS Easting:	0.0
Drain Area:	Southwest	GPS Accuracy:	Nearest Meter
Cover Shape:	Circular	Evidence of Surcharge:	Yes
Cover Size:	22.5	Potential for Runoff:	None
Comments:

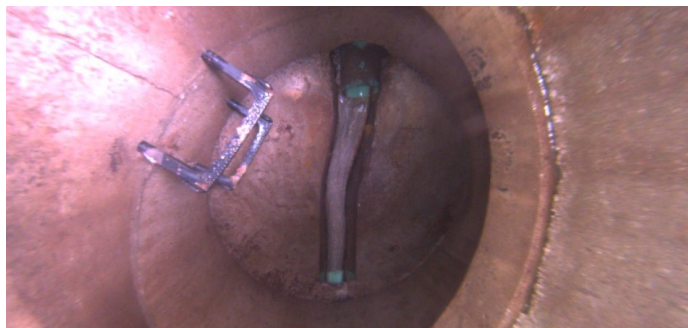
Code: **MGP**
Description: **General Photo**

Distance (ft): **.0**
Structural Grade: **0**
O&M Grade: **0**
Clock Start/From:
Clock To:
1st Value:
2nd Value:
Value Percent:
Step: **NO**
Remarks:

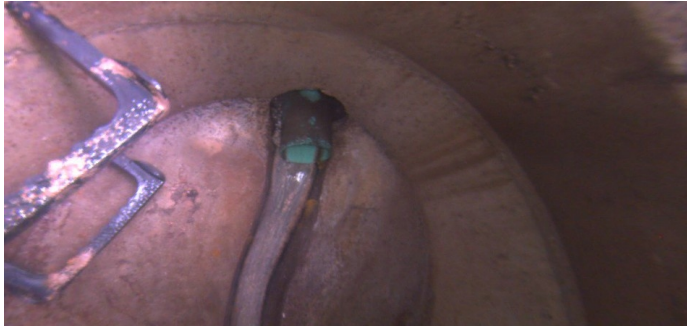
Code: **IS**
Description: **Infil Stain**

Distance (ft): **1.1**
Structural Grade: **0**
O&M Grade: **0**
Clock Start/From: **2**
Clock To:
1st Value:
2nd Value:
Value Percent:
Step: **NO**
Remarks:

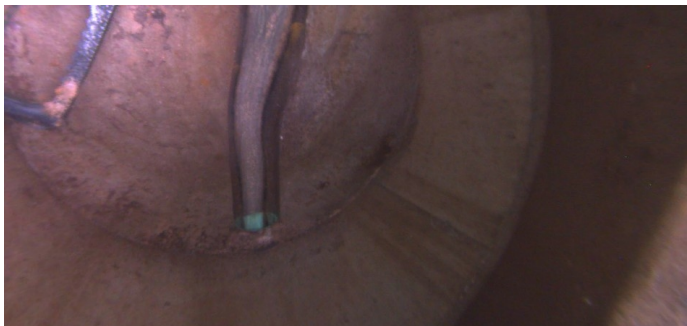
Code: **IS**
Description: **Infil Stain**

Distance (ft): **1.1**
Structural Grade: **0**
O&M Grade: **0**
Clock Start/From: **4**
Clock To:
1st Value:
2nd Value:
Value Percent:
Step: **NO**
Remarks:

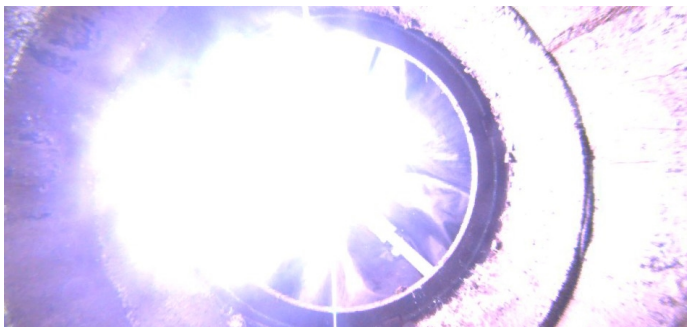
Code: **MGP**
Description: **General Photo**

Distance (ft): **2.2**
Structural Grade: **0**
O&M Grade: **0**
Clock Start/From:
Clock To:
1st Value:
2nd Value:
Value Percent:
Step: **NO**
Remarks:

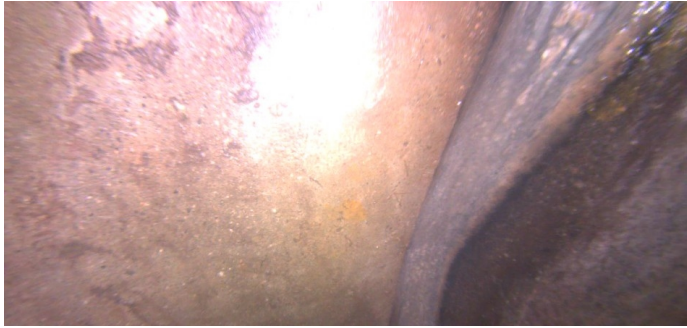
Code:	MGO
Description:	General Observation
Distance (ft):	3.6
Structural Grade:	0
O&M Grade:	0
Clock Start/From:	
Clock To:	
1st Value:	
2nd Value:	
Value Percent:	
Step:	NO
Remarks:	Ins. Comp.
