Manhole Inspection Report

Date:	04/05/2018	Weather:		Coding:	RZMACP
MH#:	M-607-074	Owner:	NA	Len. Surveyed:	8.3
P.O.#:		Surveyor:	John Kuglmaier	Rim to Invert:	9.2
Customer:		Cert. #:	U-1215-07002349	Wall Material:	Concrete (reinforced)

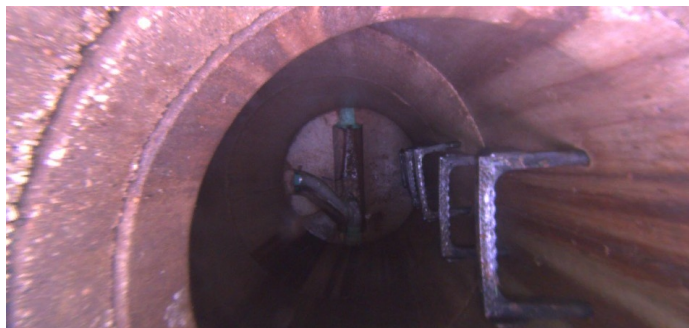
Code: **MGP**
Description: **General Photo**

Distance (ft): **.0**
Structural Grade: **0**
O&M Grade: **0**
Clock Start/From:
Clock To:
1st Value:
2nd Value:
Value Percent:
Step: **NO**
Remarks:

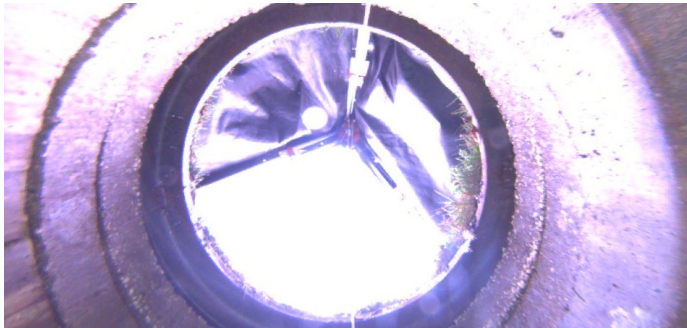
Code: **MGP**
Description: **General Photo**

Distance (ft): **2.1**
Structural Grade: **0**
O&M Grade: **0**
Clock Start/From:
Clock To:
1st Value:
2nd Value:
Value Percent:
Step: **NO**
Remarks:

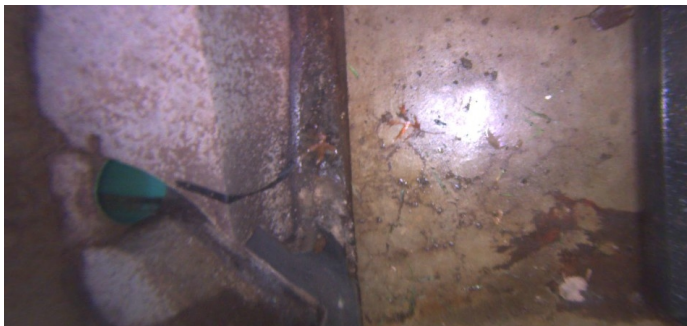
Code: **MGO**
Description: **General Observation**

Distance (ft): **7.0**
Structural Grade: **0**
O&M Grade: **0**
Clock Start/From:
Clock To:
1st Value:
2nd Value:
Value Percent:
Step: **NO**
Remarks: **Ins. Comp.**
