Manhole Inspection Report

Date:	04/25/2018	Weather:		Coding:	RZMACP
MH#:	M-607-078	Owner:	NA	Len. Surveyed:	12.1
P.O.#:		Surveyor:	John Kuglmaier	Rim to Invert:	12.1
Customer:	8.7	Cert. #:	U-1215-07002349	Wall Material:	Concrete (reinforced)

Street:	Ash St. 165' South of 10th St.	Project:	Hobart, IN
City:	Hobart, IN	GPS Northing:	0.0
Location:		GPS Easting:	0.0
Drain Area:	Southwest	GPS Accuracy:	Nearest Meter
Cover Shape:	Circular	Evidence of Surcharge:	No
Cover Size:	22.5	Potential for Runoff:	None
Comments:

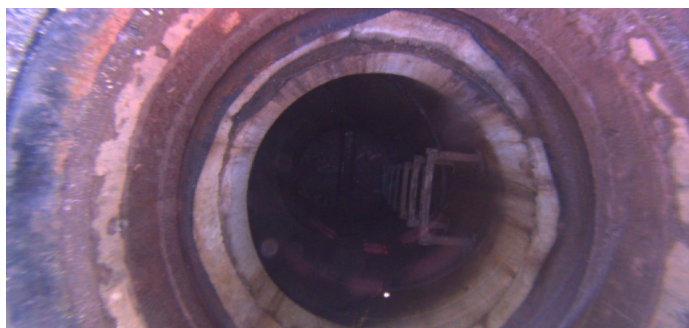
Code: **MGP**
 Description: **General Photo**

Distance (ft): **.0**
 Structural Grade: **0**
 O&M Grade: **0**
 Clock Start/From:
 Clock To:
 1st Value:
 2nd Value:
 Value Percent:
 Step: **NO**
 Remarks:

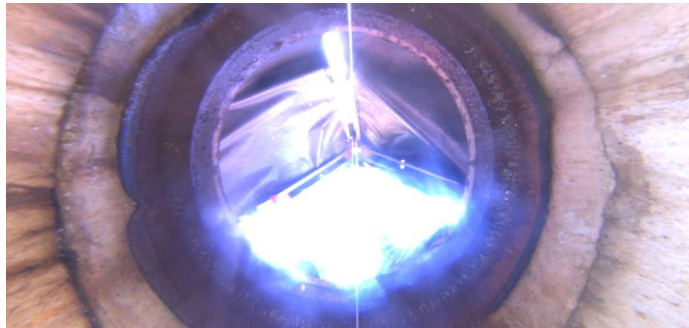
Code: **MGP**
Description: **General Photo**

Distance (ft): **3.2**
Structural Grade: **0**
O&M Grade: **0**
Clock Start/From:
Clock To:
1st Value:
2nd Value:
Value Percent:
Step: **NO**
Remarks:

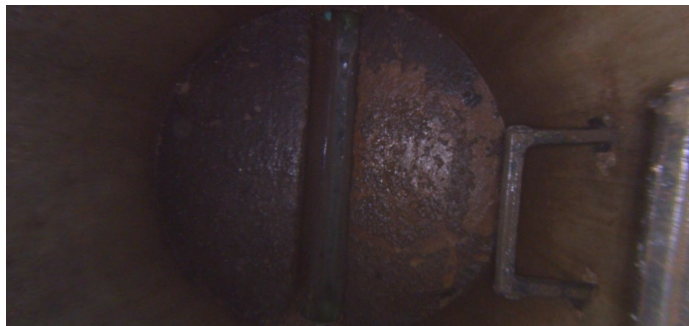
Code: **DSF**
Description: **Deposits Settled Fine**

Distance (ft): **9.4**
Structural Grade: **0**
O&M Grade: **2**
Clock Start/From: **12**
Clock To: **12**
1st Value:
2nd Value:
Value Percent: **5.000**
Step: **NO**
Remarks:

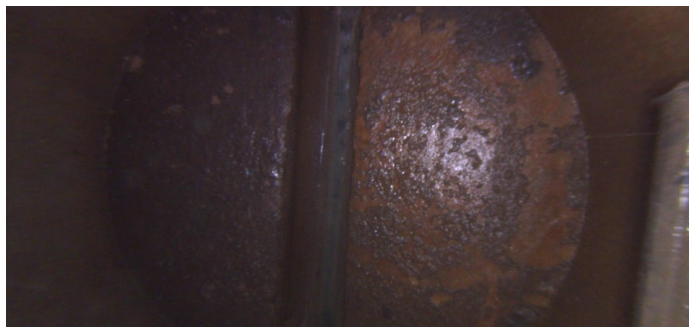
Code: **MGO**
Description: **General Observation**

Distance (ft): **10.5**
Structural Grade: **0**
O&M Grade: **0**
Clock Start/From:
Clock To:
1st Value:
2nd Value:
Value Percent:
Step: **NO**
Remarks: **Ins. Comp.**
