Manhole Inspection Report

Date:	04/25/2018	Weather:		Coding:	RZMACP
MH#:	M-607-079	Owner:	NA	Len. Surveyed:	11.2
P.O.#:		Surveyor:	John Kuglmaier	Rim to Invert:	11.4
Customer:	8.7	Cert. #:	U-1215-07002349	Wall Material:	Concrete (reinforced)

Street:	Ash St. 700' South of 10th St.	Project:	Hobart, IN
City:	Hobart, IN	GPS Northing:	0.0
Location:		GPS Easting:	0.0
Drain Area:	Southwest	GPS Accuracy:	Nearest Meter
Cover Shape:	Circular	Evidence of Surcharge:	No
Cover Size:	22.5	Potential for Runoff:	None
Comments:

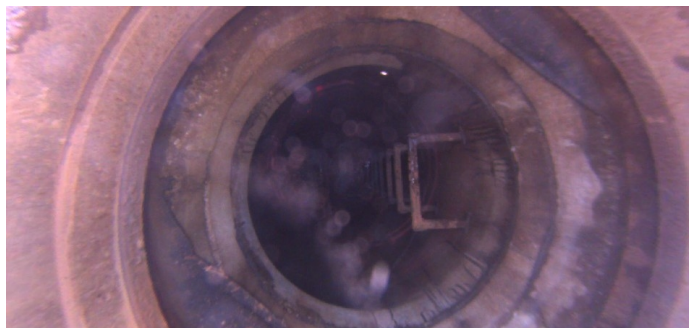
Code: **MGP**
Description: **General Photo**

Distance (ft): **.0**
Structural Grade: **0**
O&M Grade: **0**
Clock Start/From:
Clock To:
1st Value:
2nd Value:
Value Percent:
Step: **NO**
Remarks:

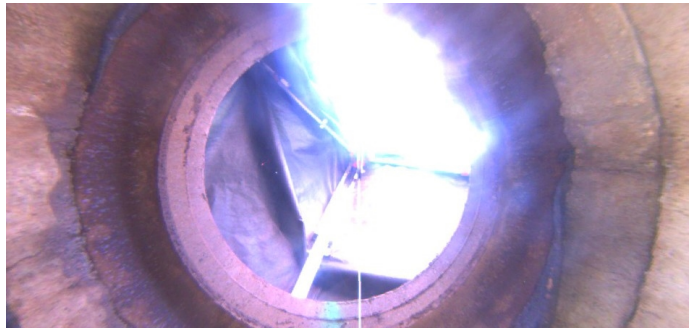
Code: **MGP**
Description: **General Photo**

Distance (ft): **2.7**
Structural Grade: **0**
O&M Grade: **0**
Clock Start/From:
Clock To:
1st Value:
2nd Value:
Value Percent:
Step: **NO**
Remarks:

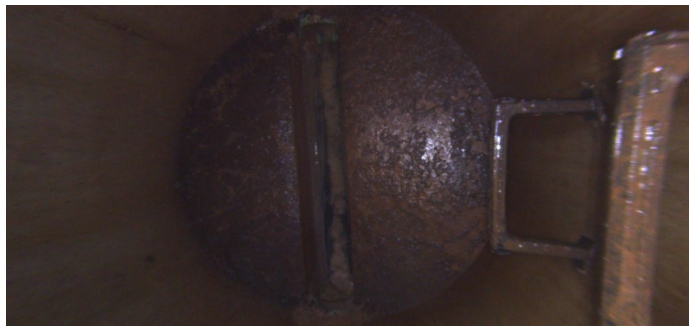
Code: **DSF**
Description: **Deposits Settled Fine**

Distance (ft): **8.6**
Structural Grade: **0**
O&M Grade: **2**
Clock Start/From: **12**
Clock To: **12**
1st Value:
2nd Value:
Value Percent: **5.000**
Step: **NO**
Remarks:

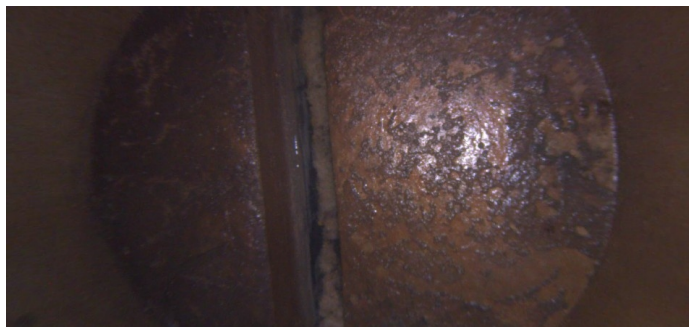
Code: **MGO**
Description: **General Observation**

Distance (ft): **9.9**
Structural Grade: **0**
O&M Grade: **0**
Clock Start/From:
Clock To:
1st Value:
2nd Value:
Value Percent:
Step: **NO**
Remarks: **Ins. Comp.**
