Manhole Inspection Report

Date:	04/06/2018	Weather:		Coding:	RZMACP
MH#:	M-607-081	Owner:	NA	Len. Surveyed:	7.0
P.O.#:		Surveyor:	John Kuglmaier	Rim to Invert:	7.9
Customer:		Cert. #:	U-1215-07002349	Wall Material:	Concrete (reinforced)

Street:	Ash St. at Intersection with 12th St.	Project:	Hobart, IN
City:	Hobart, IN	GPS Northing:	0.0
Location:		GPS Easting:	0.0
Drain Area:	Southwest	GPS Accuracy:	Nearest Meter
Cover Shape:	Circular	Evidence of Surcharge:	No
Cover Size:	22.5	Potential for Runoff:	None
Comments:

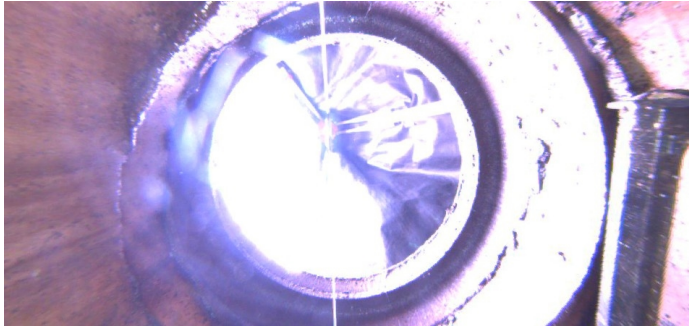
Code: **MGP**
Description: **General Photo**

Distance (ft): **2.5**
Structural Grade: **0**
O&M Grade: **0**
Clock Start/From:
Clock To:
1st Value:
2nd Value:
Value Percent:
Step: **NO**
Remarks:

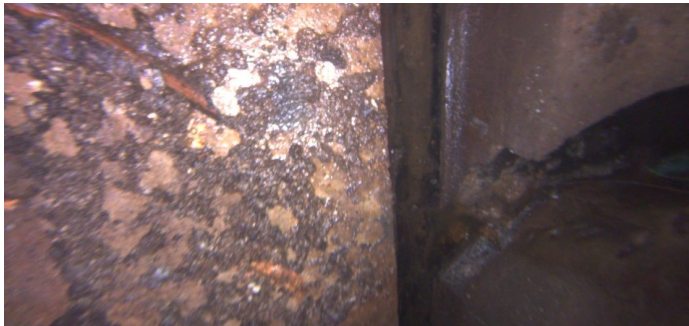
Code: **MGO**
Description: **General Observation**

Distance (ft): **6.3**
Structural Grade: **0**
O&M Grade: **0**
Clock Start/From:
Clock To:
1st Value:
2nd Value:
Value Percent:
Step: **NO**
Remarks: **Ins. Comp.**
