Manhole Inspection Report

Date:	04/06/2018	Weather:		Coding:	RZMACP
MH#:	M-607-082	Owner:	NA	Len. Surveyed:	6.8
P.O.#:		Surveyor:	John Kuglmaier	Rim to Invert:	7.5
Customer:		Cert. #:	U-1215-07002349	Wall Material:	Concrete (reinforced)

Street:	Ash St. 535' South of 12th St.	Project:	Hobart, IN
City:	Hobart, IN	GPS Northing:	0.0
Location:		GPS Easting:	0.0
Drain Area:	Southwest	GPS Accuracy:	Nearest Meter
Cover Shape:	Circular	Evidence of Surcharge:	No
Cover Size:	22.5	Potential for Runoff:	None
Comments:

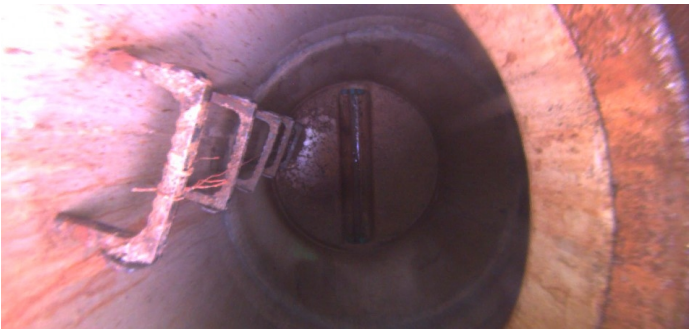
Code: **MGP**
Description: **General Photo**

Distance (ft): **.0**
Structural Grade: **0**
O&M Grade: **0**
Clock Start/From:
Clock To:
1st Value:
2nd Value:
Value Percent:
Step: **NO**
Remarks:

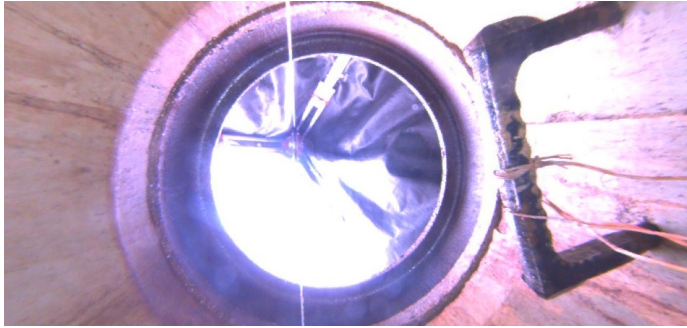
Code: **MGP**
Description: **General Photo**

Distance (ft): **2.6**
Structural Grade: **0**
O&M Grade: **0**
Clock Start/From:
Clock To:
1st Value:
2nd Value:
Value Percent:
Step: **NO**
Remarks:

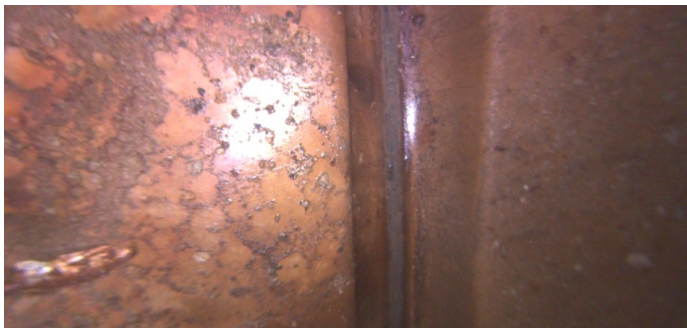
Code: **MGO**
Description: **General Observation**

Distance (ft): **5.8**
Structural Grade: **0**
O&M Grade: **0**
Clock Start/From:
Clock To:
1st Value:
2nd Value:
Value Percent:
Step: **NO**
Remarks: **Ins. Comp.**
