Manhole Inspection Report

Date:	04/06/2018	Weather:		Coding:	RZMACP
MH#:	M-607-083	Owner:	NA	Len. Surveyed:	5.3
P.O.#:		Surveyor:	John Kuglmaier	Rim to Invert:	6.1
Customer:		Cert. #:	U-1215-07002349	Wall Material:	Concrete (reinforced)

Street:	Ash St. 1015' South of 12th St.	Project:	Hobart, IN
City:	Hobart, IN	GPS Northing:	0.0
Location:		GPS Easting:	0.0
Drain Area:	Southwest	GPS Accuracy:	Nearest Meter
Cover Shape:	Circular	Evidence of Surcharge:	No
Cover Size:	22.5	Potential for Runoff:	None
Comments:

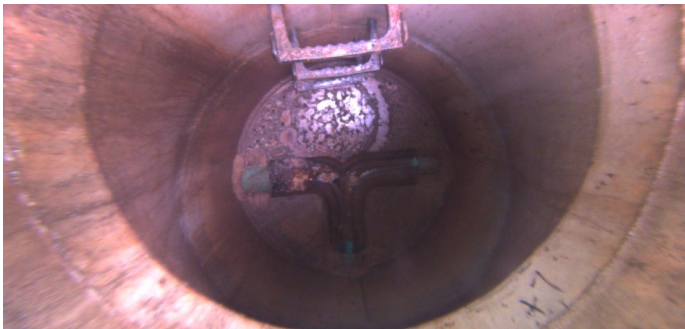
Code:	MGP
Description:	General Photo

Distance (ft):	.0
Structural Grade:	0
O&M Grade:	0
Clock Start/From:	
Clock To:	
1st Value:	
2nd Value:	
Value Percent:	
Step:	NO
Remarks:

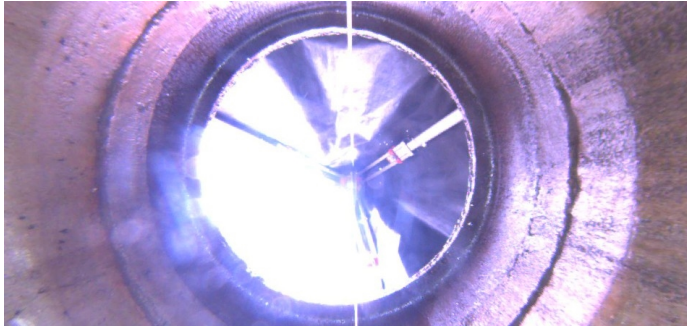
Code: **MGP**
Description: **General Photo**

Distance (ft): **2.3**
Structural Grade: **0**
O&M Grade: **0**
Clock Start/From:
Clock To:
1st Value:
2nd Value:
Value Percent:
Step: **NO**
Remarks:

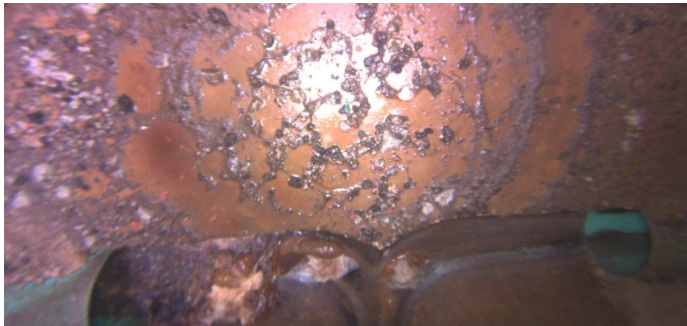
Code: **MGO**
Description: **General Observation**

Distance (ft): **4.3**
Structural Grade: **0**
O&M Grade: **0**
Clock Start/From:
Clock To:
1st Value:
2nd Value:
Value Percent:
Step: **NO**
Remarks: **Ins. Comp.**
