# Manhole Inspection Report

Date:	<b>04/06/2018</b>	Weather:		Coding:	<b>RZMACP</b>
MH#:	<b>M-607-083A</b>	Owner:	<b>NA</b>	Len. Surveyed:	<b>6.7</b>
P.O.#:		Surveyor:	<b>John Kuglmaier</b>	Rim to Invert:	<b>7.2</b>
Customer:		Cert. #:	<b>U-1215-07002349</b>	Wall Material:	<b>Concrete (reinforced)</b>

Street:	<b>Ash St. 1015' South of 12th St.</b>	Project:	<b>Hobart, IN</b>
City:	<b>Hobart, IN</b>	GPS Northing:	<b>0.0</b>
Location:		GPS Easting:	<b>0.0</b>
Drain Area:	<b>Southwest</b>	GPS Accuracy:	<b>Nearest Meter</b>
Cover Shape:	<b>Circular</b>	Evidence of Surcharge:	<b>No</b>
Cover Size:	<b>22.5</b>	Potential for Runoff:	<b>None</b>
Comments:

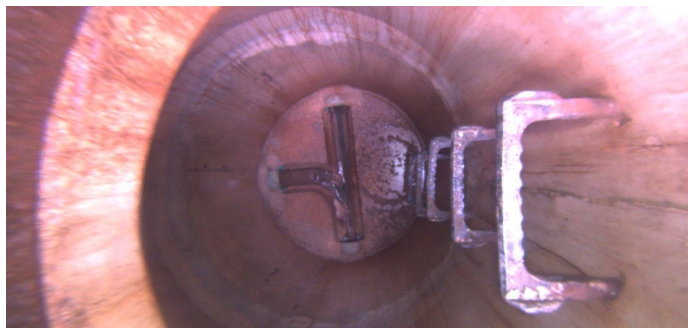
Code: **MGP**  
Description: **General Photo**

Distance (ft): **.0**  
Structural Grade: **0**  
O&M Grade: **0**  
Clock Start/From:  
Clock To:  
1st Value:  
2nd Value:  
Value Percent:  
Step: **NO**  
Remarks:

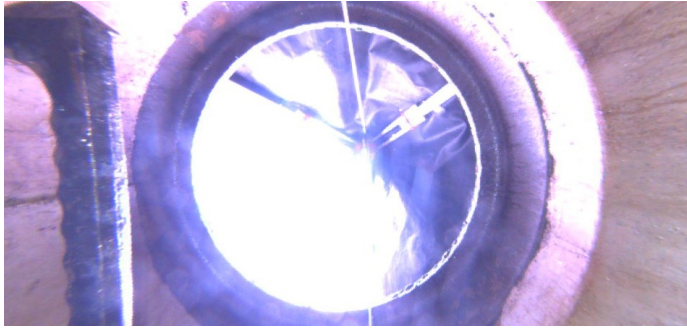
Code: **MGP**  
Description: **General Photo**

Distance (ft): **2.4**  
Structural Grade: **0**  
O&M Grade: **0**  
Clock Start/From:  
Clock To:  
1st Value:  
2nd Value:  
Value Percent:  
Step: **NO**  
Remarks:

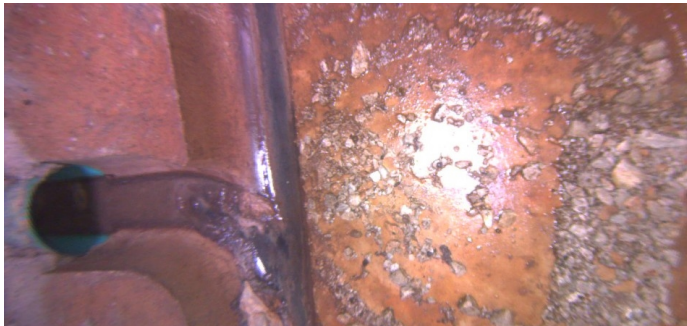
Code: **MGO**  
Description: **General Observation**

Distance (ft): **5.7**  
Structural Grade: **0**  
O&M Grade: **0**  
Clock Start/From:  
Clock To:  
1st Value:  
2nd Value:  
Value Percent:  
Step: **NO**  
Remarks: **Ins. Comp.**
