Manhole Inspection Report

Date:	04/06/2018	Weather:		Coding:	RZMACP
MH#:	M-607-085	Owner:	NA	Len. Surveyed:	.9
P.O.#:		Surveyor:	John Kuglmaier	Rim to Invert:	1.0
Customer:		Cert. #:	U-1215-07002349	Wall Material:	Concrete (reinforced)

Street:	Connecticut St. 425' South of 12th St	Project:	Hobart, IN
City:	Hobart, IN	GPS Northing:	0.0
Location:		GPS Easting:	0.0
Drain Area:	Southwest	GPS Accuracy:	Nearest Meter
Cover Shape:	Circular	Evidence of Surcharge:	Yes
Cover Size:	22.5	Potential for Runoff:	None
Comments:

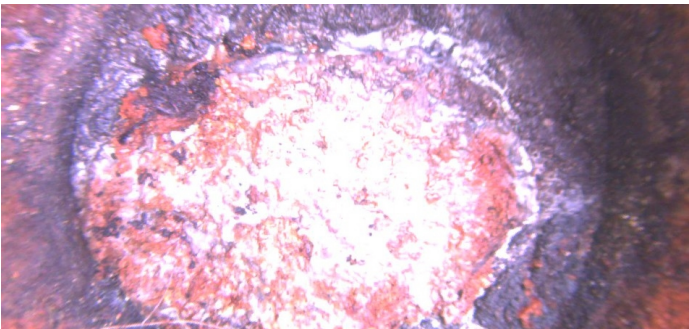
Code: **MGP**
Description: **General Photo**

Distance (ft): **.0**
Structural Grade: **0**
O&M Grade: **0**
Clock Start/From:
Clock To:
1st Value:
2nd Value:
Value Percent:
Step: **NO**
Remarks:

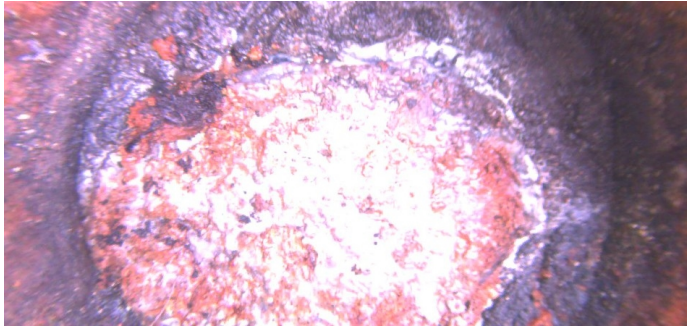
Code: **MGO**
Description: **General Observation**

Distance (ft): **.1**
Structural Grade: **0**
O&M Grade: **0**
Clock Start/From:
Clock To:
1st Value:
2nd Value:
Value Percent:
Step: **NO**
Remarks: **Surcharge**

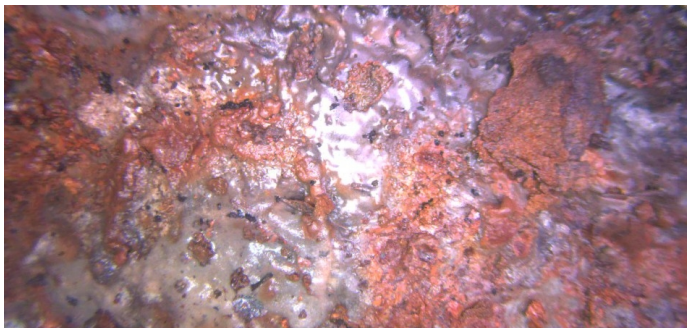
Code: **MSA**
Description: **Abandoned Survey**

Distance (ft): **.8**
Structural Grade: **0**
O&M Grade: **0**
Clock Start/From:
Clock To:
1st Value:
2nd Value:
Value Percent:
Step: **NO**
Remarks: **Surcharge**
