Manhole Inspection Report

Date:	04/05/2018	Weather:		Coding:	RZMACP
MH#:	M-608-002	Owner:	NA	Len. Surveyed:	6.8
P.O.#:		Surveyor:	John Kuglmaier	Rim to Invert:	6.7
Customer:		Cert. #:	U-1215-07002349	Wall Material:	Concrete (reinforced)

Street:	Wisconsin St. 260' North of 61st Ave	Project:	Hobart, IN
City:	Hobart, IN	GPS Northing:	0.0
Location:		GPS Easting:	0.0
Drain Area:	Southwest	GPS Accuracy:	Nearest Meter
Cover Shape:	Circular	Evidence of Surcharge:	No
Cover Size:	22.5	Potential for Runoff:	None
Comments:

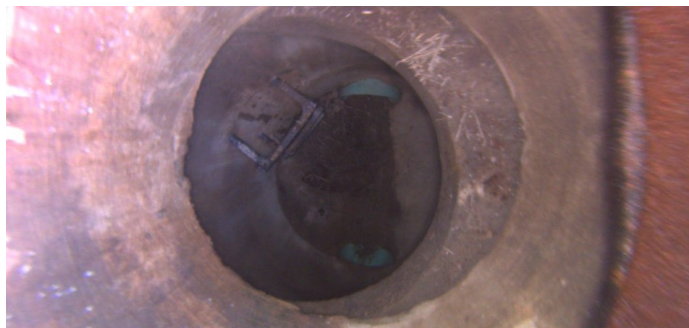
Code: **MGP**
Description: **General Photo**

Distance (ft): **.0**
Structural Grade: **0**
O&M Grade: **0**
Clock Start/From:
Clock To:
1st Value:
2nd Value:
Value Percent:
Step: **NO**
Remarks:

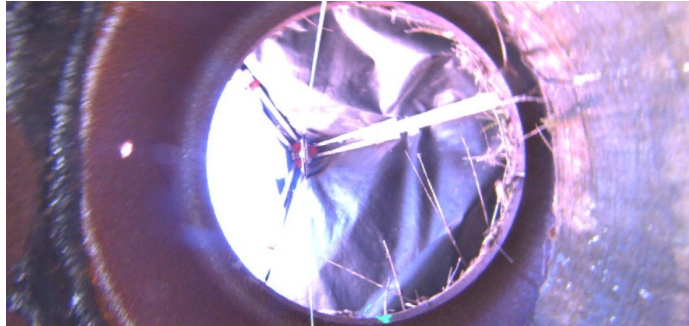
Code: **MGP**
Description: **General Photo**

Distance (ft): **2.0**
Structural Grade: **0**
O&M Grade: **0**
Clock Start/From:
Clock To:
1st Value:
2nd Value:
Value Percent:
Step: **NO**
Remarks:

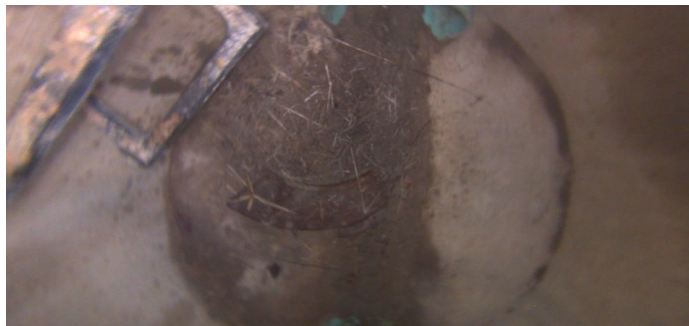
Code: **DAZ**
Description: **Deposits Attached Other**

Distance (ft): **3.7**
Structural Grade: **0**
O&M Grade: **2**
Clock Start/From: **6**
Clock To: **12**
1st Value:
2nd Value:
Value Percent: **5.000**
Step: **NO**
Remarks: **Mixed materials**

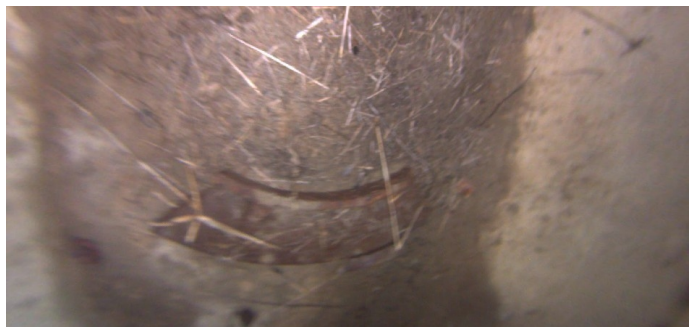
Code: **OBZ**
Description: **Obstacle Other**

Distance (ft): **5.0**
Structural Grade: **0**
O&M Grade: **2**
Clock Start/From: **6**
Clock To: **8**
1st Value:
2nd Value:
Value Percent: **5.000**
Step: **NO**
Remarks: **Metal**

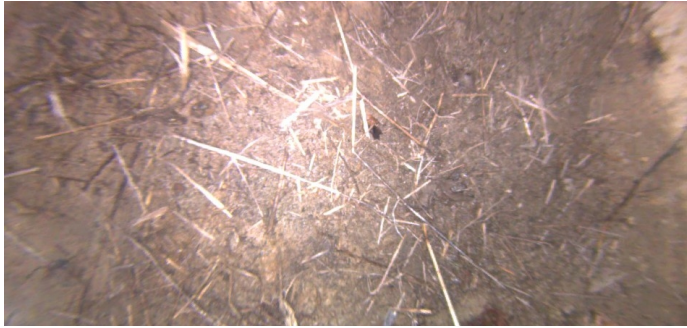
Code:	MGO
Description:	General Observation
Distance (ft):	5.9
Structural Grade:	0
O&M Grade:	0
Clock Start/From:	
Clock To:	
1st Value:	
2nd Value:	
Value Percent:	
Step:	NO
Remarks:	Ins. Comp.
