Manhole Inspection Report

Date:	04/05/2018	Weather:		Coding:	RZMACP
MH#:	M-608-003	Owner:	NA	Len. Surveyed:	7.9
P.O.#:		Surveyor:	John Kuglmaier	Rim to Invert:	7.6
Customer:		Cert. #:	U-1215-07002349	Wall Material:	Concrete (reinforced)

Street:	Wisconsin St. 660' North of 61st Ave	Project:	Hobart, IN
City:	Hobart, IN	GPS Northing:	0.0
Location:		GPS Easting:	0.0
Drain Area:	Southwest	GPS Accuracy:	Nearest Meter
Cover Shape:	Circular	Evidence of Surcharge:	No
Cover Size:	22.5	Potential for Runoff:	None
Comments:

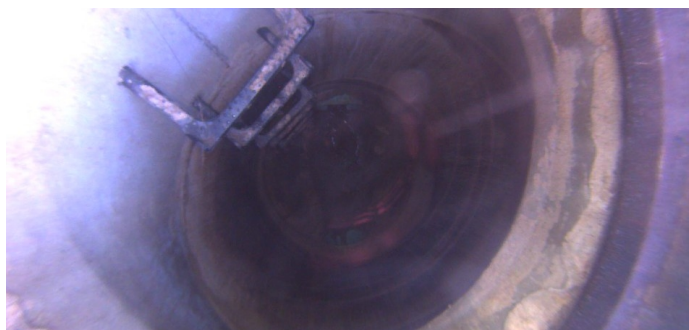
Code: **MGP**
Description: **General Photo**

Distance (ft): **.0**
Structural Grade: **0**
O&M Grade: **0**
Clock Start/From:
Clock To:
1st Value:
2nd Value:
Value Percent:
Step: **NO**
Remarks:

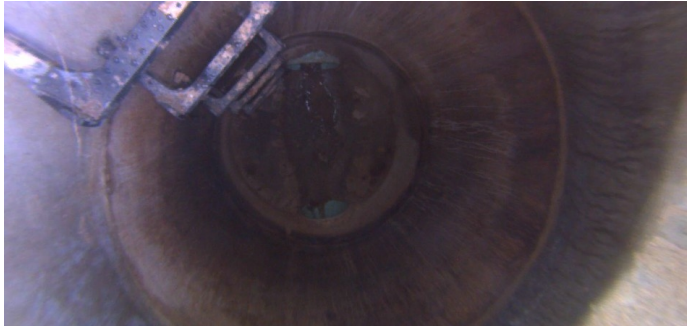
Code: **IS**
Description: **Infil Stain**

Distance (ft): **.7**
Structural Grade: **0**
O&M Grade: **0**
Clock Start/From: **12**
Clock To: **12**
1st Value:
2nd Value:
Value Percent:
Step: **NO**
Remarks:

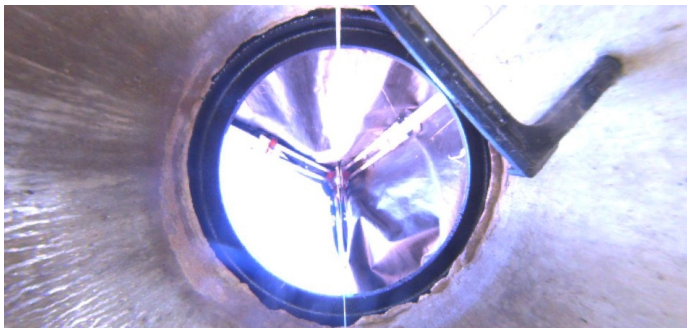
Code: **MGP**
Description: **General Photo**

Distance (ft): **2.9**
Structural Grade: **0**
O&M Grade: **0**
Clock Start/From:
Clock To:
1st Value:
2nd Value:
Value Percent:
Step: **NO**
Remarks:

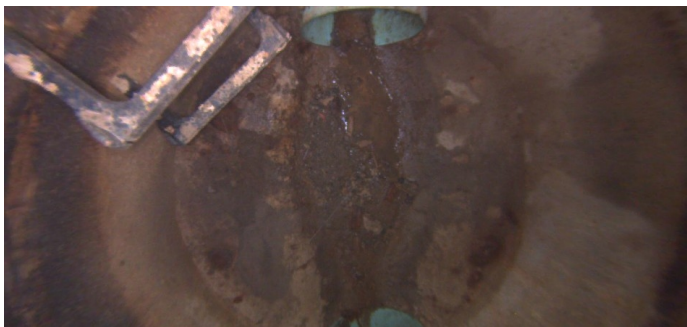
Code: **DSF**
Description: **Deposits Settled Fine**

Distance (ft): **4.8**
Structural Grade: **0**
O&M Grade: **2**
Clock Start/From: **12**
Clock To: **12**
1st Value:
2nd Value:
Value Percent: **5.000**
Step: **NO**
Remarks:

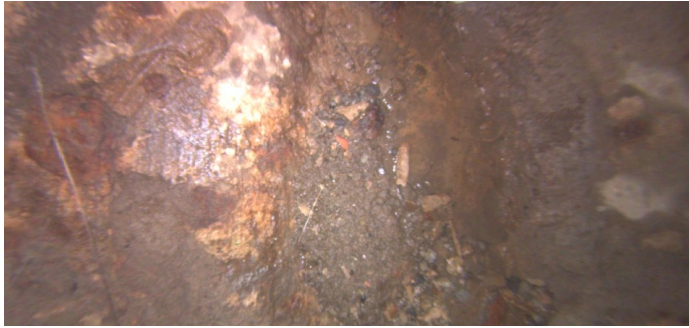
Code:	MGO
Description:	General Observation
Distance (ft):	6.8
Structural Grade:	0
O&M Grade:	0
Clock Start/From:	
Clock To:	
1st Value:	
2nd Value:	
Value Percent:	
Step:	NO
Remarks:	Ins. Comp.
