Manhole Inspection Report

Date:	04/05/2018	Weather:		Coding:	RZMACP
MH#:	M-608-004	Owner:	NA	Len. Surveyed:	7.7
P.O.#:		Surveyor:	John Kuglmaier	Rim to Invert:	7.6
Customer:		Cert. #:	U-1215-07002349	Wall Material:	Concrete (reinforced)

Street:	Wisconsin St. 415' South of 14th St.	Project:	Hobart, IN
City:	Hobart, IN	GPS Northing:	0.0
Location:		GPS Easting:	0.0
Drain Area:	Southwest	GPS Accuracy:	Nearest Meter
Cover Shape:	Circular	Evidence of Surcharge:	Yes
Cover Size:	22.5	Potential for Runoff:	None
Comments:

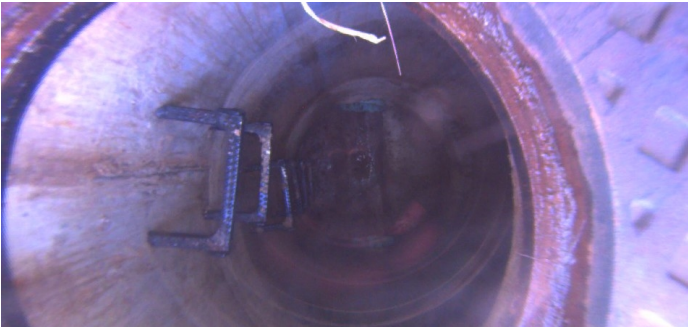
Code:

MGP

Description:

General Photo

Distance (ft):

.0

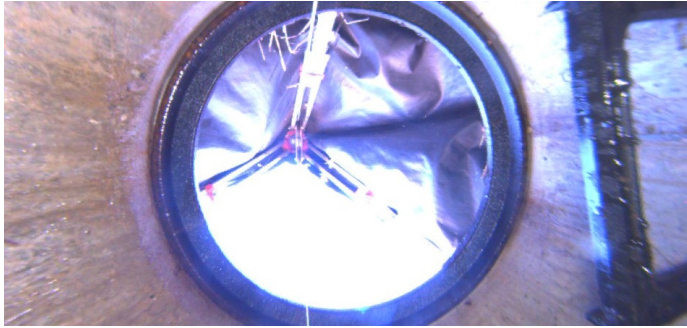
Code: **MGP**
Description: **General Photo**

Distance (ft): **2.7**
Structural Grade: **0**
O&M Grade: **0**
Clock Start/From:
Clock To:
1st Value:
2nd Value:
Value Percent:
Step: **NO**
Remarks:

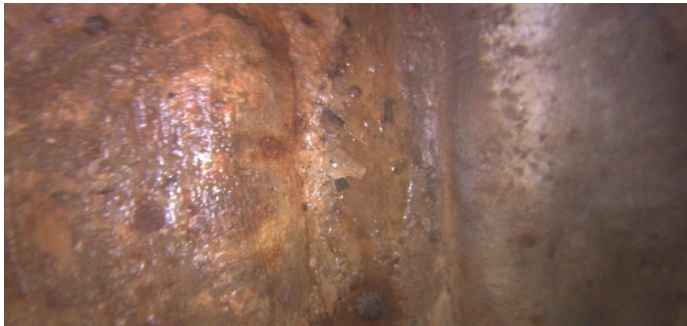
Code: **MGO**
Description: **General Observation**

Distance (ft): **6.7**
Structural Grade: **0**
O&M Grade: **0**
Clock Start/From:
Clock To:
1st Value:
2nd Value:
Value Percent:
Step: **NO**
Remarks: **Ins. Comp.**
