Date:	04/07/2018	Weather:		Coding:	RZMACP
MH#:	M-608-005	Owner:	NA	Len. Surveyed:	10.6
P.O.#:		Surveyor:	John Kuglmaier	Rim to Invert:	10.9
Customer:		Cert. #:	U-1215-07002349	Wall Material:	Concrete (reinforced)
Street:	Lake Park Ave. and 61st Ave. The So		Project:	Hobart, IN	
City:	Hobart, IN	(GPS Northing:	0.0	
Location:		(GPS Easting:	0.0	
Drain Area:	Southwest	(GPS Accuracy:	Nearest Meter	
Cover Shape:	Circular	E	Evidence of Surcharge:	No	
Cover Size: Comments:	22.5	F	Potential for Runoff:	None	
O&M Index:	2.00	O&M Quick:	2100	O&M Rating:	2.00
Structural Index:	0.00	Structural Quic	ck: 0000	Structural Rating:	0.00
Overall Index:	2.00	Overall Quick:	2100	Overall Rating:	2.00

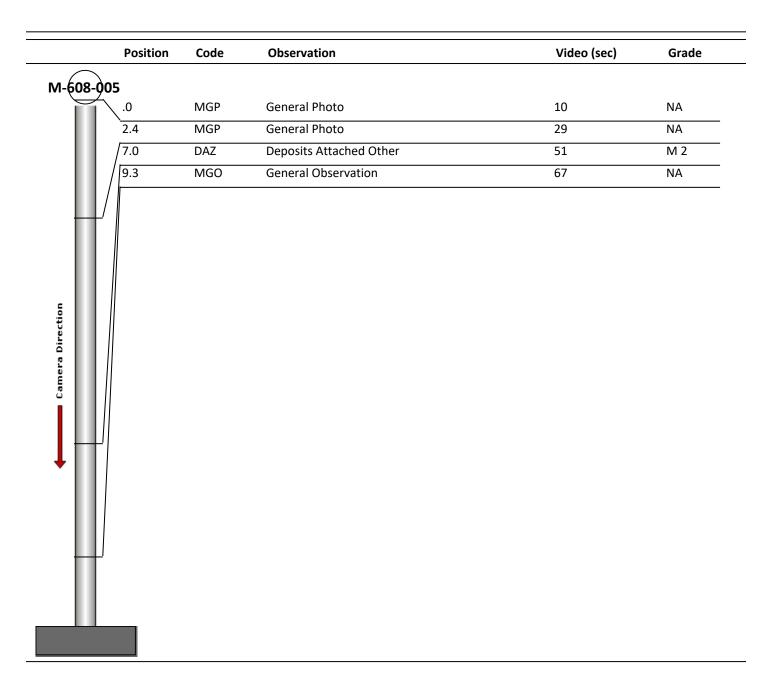
Code: Description:	MGP General Photo
Distance (ft):	.0
Structural Grade:	0
O&M Grade:	0
Clock Start/From:	
Clock To:	
1st Value:	
2nd Value:	
Value Percent:	
Step:	NO
Remarks:
