Manhole Inspection Report

Date:	04/07/2018	Weather:		Coding:	RZMACP
MH#:	M-608-008	Owner:	NA	Len. Surveyed:	5.7
P.O.#:		Surveyor:	John Kuglmaier	Rim to Invert:	6.1
Customer:		Cert. #:	U-1215-07002349	Wall Material:	Concrete (reinforced)

Street:	296' South of 61st Ave. 491' West of	Project:	Hobart, IN
City:	Hobart, IN	GPS Northing:	0.0
Location:		GPS Easting:	0.0
Drain Area:	Southwest	GPS Accuracy:	Nearest Meter
Cover Shape:	Circular	Evidence of Surcharge:	No
Cover Size:	22.5	Potential for Runoff:	None
Comments:

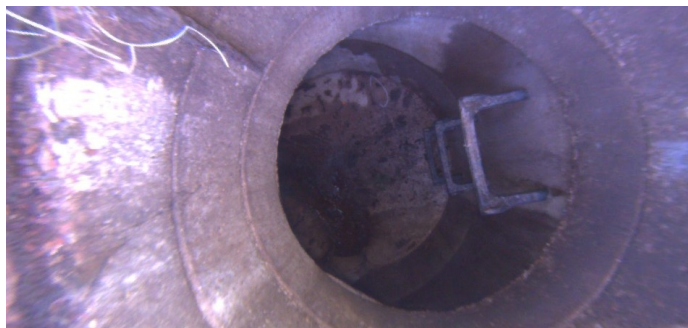
Code: **MGP**
Description: **General Photo**

Distance (ft): **.0**
Structural Grade: **0**
O&M Grade: **0**
Clock Start/From:
Clock To:
1st Value:
2nd Value:
Value Percent:
Step: **NO**
Remarks:

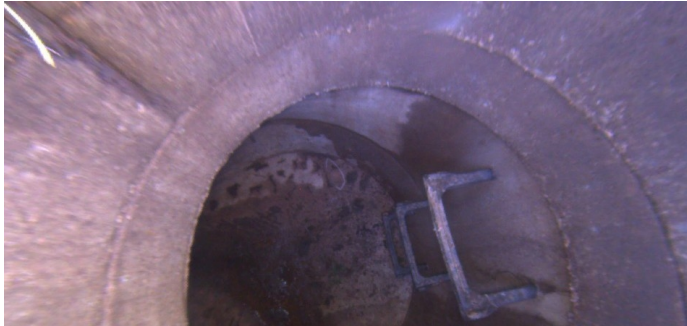
Code: **IS**
Description: **Infil Stain**

Distance (ft): **.5**
Structural Grade: **0**
O&M Grade: **0**
Clock Start/From: **1**
Clock To:
1st Value:
2nd Value:
Value Percent:
Step: **NO**
Remarks:

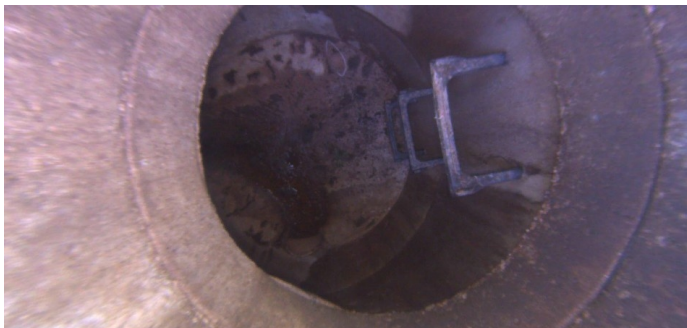
Code: **IS**
Description: **Infil Stain**

Distance (ft): **.5**
Structural Grade: **0**
O&M Grade: **0**
Clock Start/From: **4**
Clock To: **6**
1st Value:
2nd Value:
Value Percent:
Step: **NO**
Remarks:

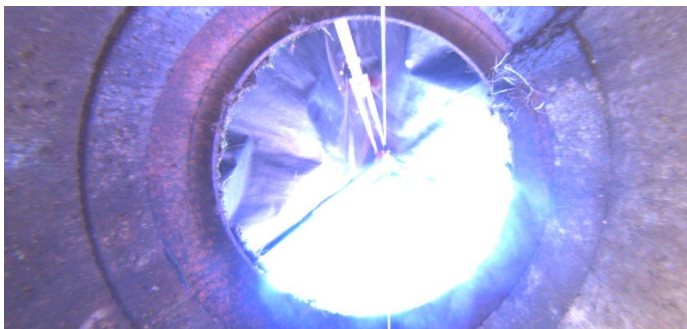
Code: **MGP**
Description: **General Photo**

Distance (ft): **2.2**
Structural Grade: **0**
O&M Grade: **0**
Clock Start/From:
Clock To:
1st Value:
2nd Value:
Value Percent:
Step: **NO**
Remarks:

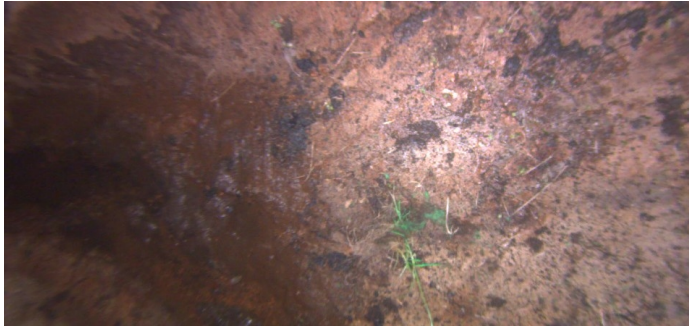
Code:	MGO
Description:	General Observation
Distance (ft):	4.8
Structural Grade:	0
O&M Grade:	0
Clock Start/From:	
Clock To:	
1st Value:	
2nd Value:	
Value Percent:	
Step:	NO
Remarks:	Ins. Comp.
