Manhole Inspection Report

Date:	04/07/2018	Weather:		Coding:	RZMACP
MH#:	M-608-009	Owner:	NA	Len. Surveyed:	6.6
P.O.#:		Surveyor:	John Kuglmaier	Rim to Invert:	6.9
Customer:		Cert. #:	U-1215-07002349	Wall Material:	Concrete (reinforced)

Street:	297' South of 61st Ave. 401' West of	Project:	Hobart, IN
City:	Hobart, IN	GPS Northing:	0.0
Location:		GPS Easting:	0.0
Drain Area:	Southwest	GPS Accuracy:	Nearest Meter
Cover Shape:	Circular	Evidence of Surcharge:	No
Cover Size:	22.5	Potential for Runoff:	None
Comments:

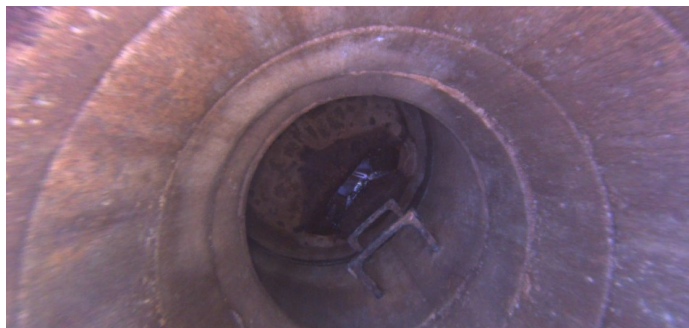
Code: **MGP**
Description: **General Photo**

Distance (ft): **.0**
Structural Grade: **0**
O&M Grade: **0**
Clock Start/From:
Clock To:
1st Value:
2nd Value:
Value Percent:
Step: **NO**
Remarks:

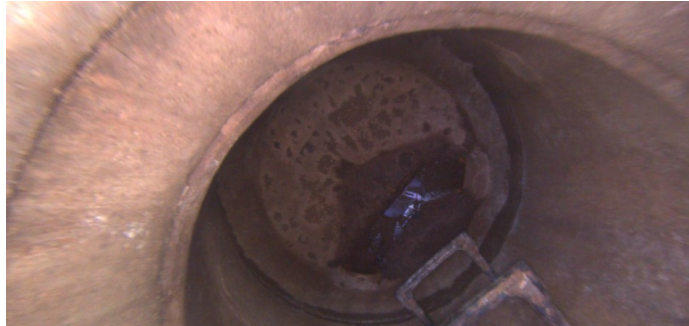
Code: **IS**
Description: **Infil Stain**

Distance (ft): **1.6**
Structural Grade: **0**
O&M Grade: **0**
Clock Start/From: **12**
Clock To: **12**
1st Value:
2nd Value:
Value Percent:
Step: **NO**
Remarks:

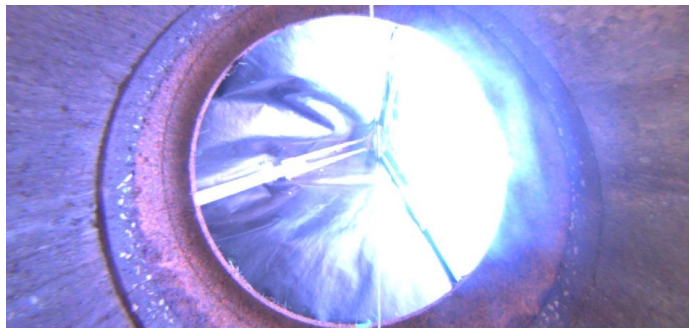
Code: **MGP**
Description: **General Photo**

Distance (ft): **2.1**
Structural Grade: **0**
O&M Grade: **0**
Clock Start/From:
Clock To:
1st Value:
2nd Value:
Value Percent:
Step: **NO**
Remarks:

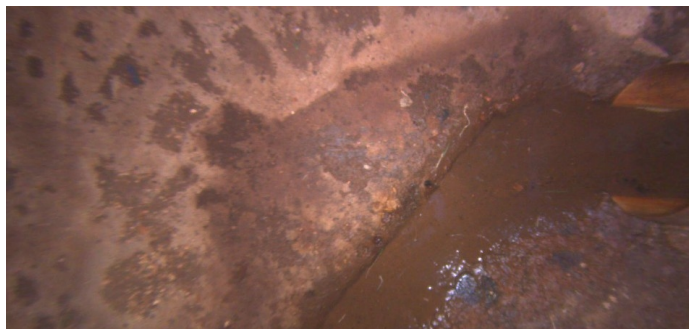
Code: **MGO**
Description: **General Observation**

Distance (ft): **5.3**
Structural Grade: **0**
O&M Grade: **0**
Clock Start/From:
Clock To:
1st Value:
2nd Value:
Value Percent:
Step: **NO**
Remarks: **Ins. Comp.**
