Manhole Inspection Report

Date:	04/07/2018	Weather:		Coding:	RZMACP
MH#:	M-608-010	Owner:	NA	Len. Surveyed:	7.6
P.O.#:		Surveyor:	John Kuglmaier	Rim to Invert:	7.0
Customer:		Cert. #:	U-1215-07002349	Wall Material:	Concrete (reinforced)

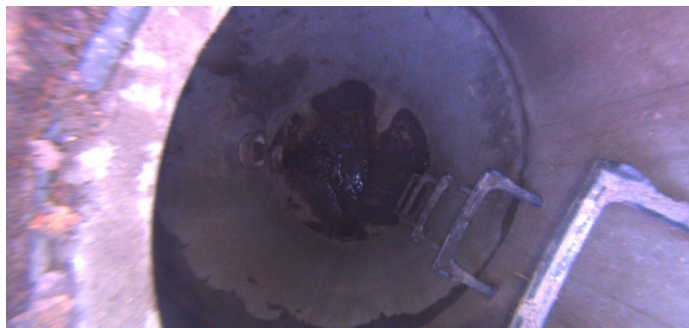
Code: **MGP**
Description: **General Photo**

Distance (ft): **.0**
Structural Grade: **0**
O&M Grade: **0**
Clock Start/From:
Clock To:
1st Value:
2nd Value:
Value Percent:
Step: **NO**
Remarks:

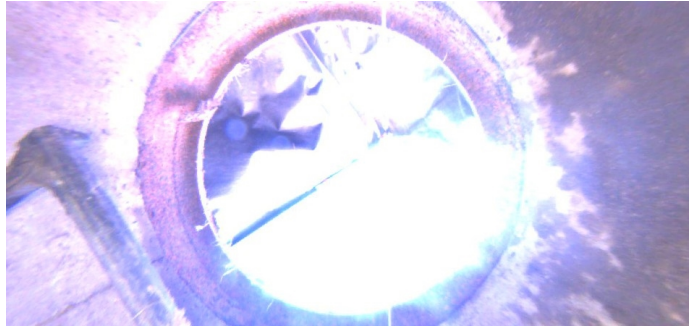
Code: **MGP**
Description: **General Photo**

Distance (ft): **2.4**
Structural Grade: **0**
O&M Grade: **0**
Clock Start/From:
Clock To:
1st Value:
2nd Value:
Value Percent:
Step: **NO**
Remarks:

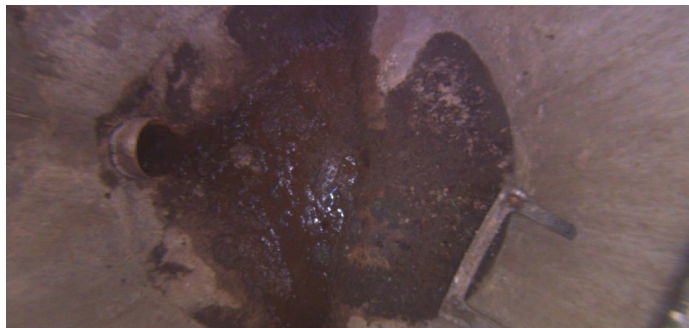
Code: **DSF**
Description: **Deposits Settled Fine**

Distance (ft): **4.7**
Structural Grade: **0**
O&M Grade: **2**
Clock Start/From: **12**
Clock To: **12**
1st Value:
2nd Value:
Value Percent: **5.000**
Step: **NO**
Remarks:

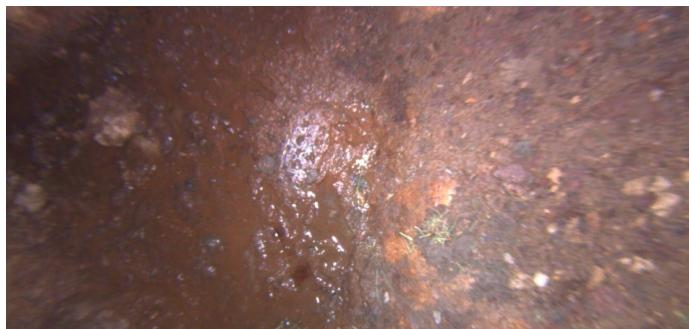
Code: **MGO**
Description: **General Observation**

Distance (ft): **6.5**
Structural Grade: **0**
O&M Grade: **0**
Clock Start/From:
Clock To:
1st Value:
2nd Value:
Value Percent:
Step: **NO**
Remarks: **Ins. Comp.**
