Manhole Inspection Report

Date:	04/08/2018	Weather:		Coding:	RZMACP
MH#:	M-608-012	Owner:	NA	Len. Surveyed:	6.3
P.O.#:		Surveyor:	John Kuglmaier	Rim to Invert:	7.1
Customer:		Cert. #:	U-1215-07002349	Wall Material:	Concrete (reinforced)

Street:	On West 61st St. 273' North of 61st	Project:	Hobart, IN
City:	Hobart, IN	GPS Northing:	2903320.851
Location:		GPS Easting:	2903320.851
Drain Area:	Southwest	GPS Accuracy:	Sub-Meter
Cover Shape:	Circular	Evidence of Surcharge:	No
Cover Size:	22.5	Potential for Runoff:	None
Comments:

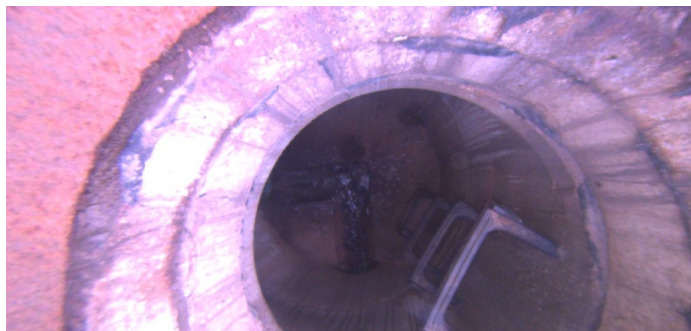
Code: **MGP**
 Description: **General Photo**

Distance (ft): **.0**
 Structural Grade: **0**
 O&M Grade: **0**
 Clock Start/From:
 Clock To:
 1st Value:
 2nd Value:
 Value Percent:
 Step: **NO**
 Remarks:

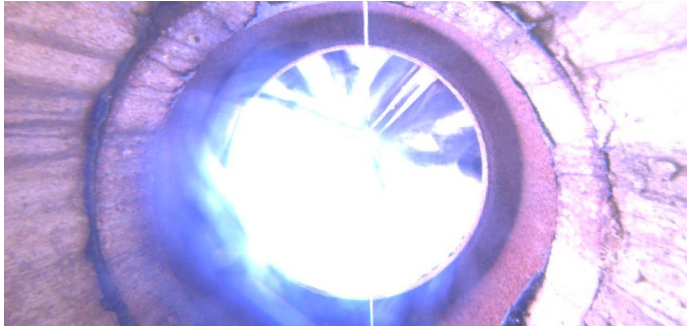
Code: **MGP**
Description: **General Photo**

Distance (ft): **2.3**
Structural Grade: **0**
O&M Grade: **0**
Clock Start/From:
Clock To:
1st Value:
2nd Value:
Value Percent:
Step: **NO**
Remarks:

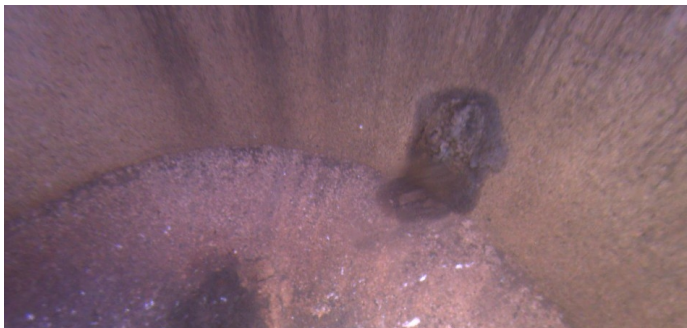
Code: **IS**
Description: **Infil Stain**

Distance (ft): **4.7**
Structural Grade: **0**
O&M Grade: **0**
Clock Start/From: **1**
Clock To:
1st Value:
2nd Value:
Value Percent:
Step: **NO**
Remarks:

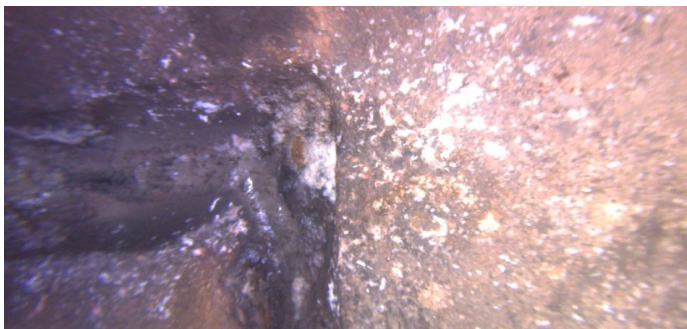
Code: **MGO**
Description: **General Observation**

Distance (ft): **5.5**
Structural Grade: **0**
O&M Grade: **0**
Clock Start/From:
Clock To:
1st Value:
2nd Value:
Value Percent:
Step: **NO**
Remarks: **Ins. Comp.**
