Manhole Inspection Report

Date:	04/08/2018	Weather:		Coding:	RZMACP
MH#:	M-608-013	Owner:	NA	Len. Surveyed:	8.5
P.O.#:		Surveyor:	John Kuglmaier	Rim to Invert:	8.6
Customer:		Cert. #:	U-1215-07002349	Wall Material:	Concrete (reinforced)

Street:	On West 61st St. 464' North of 61st	Project:	Hobart, IN
City:	Hobart, IN	GPS Northing:	2903321.006
Location:		GPS Easting:	2903321.006
Drain Area:	Southwest	GPS Accuracy:	Sub-Meter
Cover Shape:	Circular	Evidence of Surcharge:	Yes
Cover Size:	22.5	Potential for Runoff:	None
Comments:

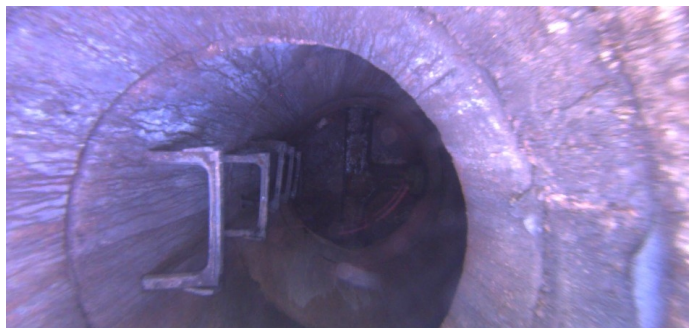
Code: **MGP**
Description: **General Photo**

Distance (ft): **.0**
Structural Grade: **0**
O&M Grade: **0**
Clock Start/From:
Clock To:
1st Value:
2nd Value:
Value Percent:
Step: **NO**
Remarks:

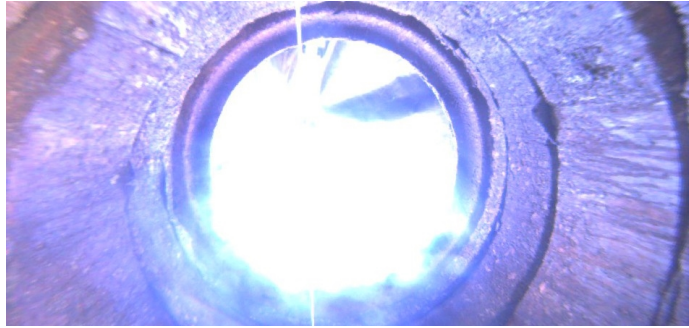
Code: **MGP**
Description: **General Photo**

Distance (ft): **2.4**
Structural Grade: **0**
O&M Grade: **0**
Clock Start/From:
Clock To:
1st Value:
2nd Value:
Value Percent:
Step: **NO**
Remarks:

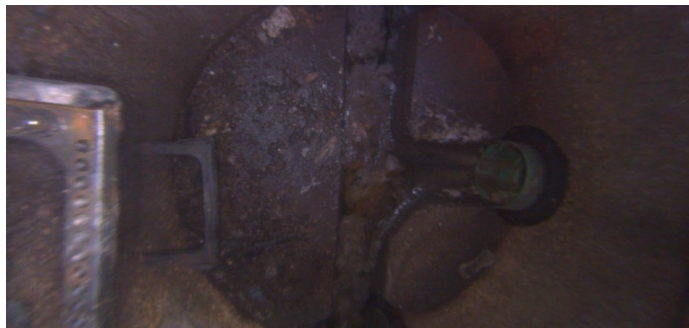
Code: **DAZ**
Description: **Deposits Attached Other**

Distance (ft): **5.6**
Structural Grade: **0**
O&M Grade: **2**
Clock Start/From: **12**
Clock To: **12**
1st Value:
2nd Value:
Value Percent: **5.000**
Step: **NO**
Remarks: **Mixed materials**

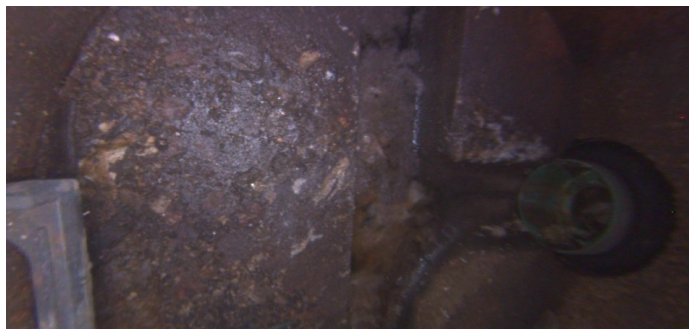
Code: **MGO**
Description: **General Observation**

Distance (ft): **7.0**
Structural Grade: **0**
O&M Grade: **0**
Clock Start/From:
Clock To:
1st Value:
2nd Value:
Value Percent:
Step: **NO**
Remarks: **Ins. Comp.**
