Manhole Inspection Report

Date:	04/08/2018	Weather:		Coding:	RZMACP
MH#:	M-608-016	Owner:	NA	Len. Surveyed:	4.8
P.O.#:		Surveyor:	John Kuglmaier	Rim to Invert:	5.2
Customer:		Cert. #:	U-1215-07002349	Wall Material:	Concrete (reinforced)

Street:	400' North of 61st Ave. 740' East of	Project:	Hobart, IN
City:	Hobart, IN	GPS Northing:	2904087.331
Location:		GPS Easting:	2904087.331
Drain Area:	Southwest	GPS Accuracy:	Sub-Meter
Cover Shape:	Circular	Evidence of Surcharge:	Yes
Cover Size:	22.5	Potential for Runoff:	None
Comments:

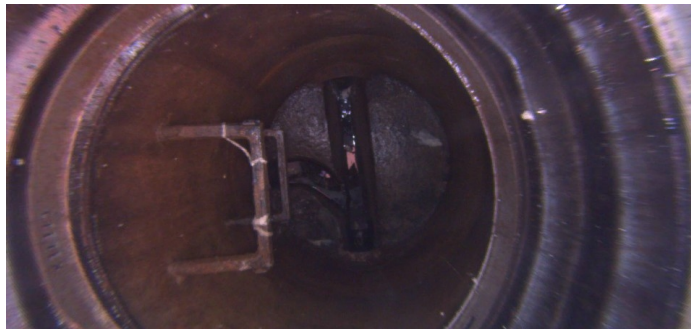
Code: **MGP**
Description: **General Photo**

Distance (ft): **.0**
Structural Grade: **0**
O&M Grade: **0**
Clock Start/From:
Clock To:
1st Value:
2nd Value:
Value Percent:
Step: **NO**
Remarks:

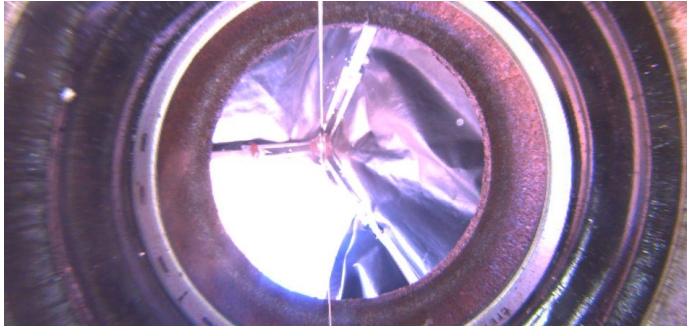
Code: **MGP**
Description: **General Photo**

Distance (ft): **2.2**
Structural Grade: **0**
O&M Grade: **0**
Clock Start/From:
Clock To:
1st Value:
2nd Value:
Value Percent:
Step: **NO**
Remarks:

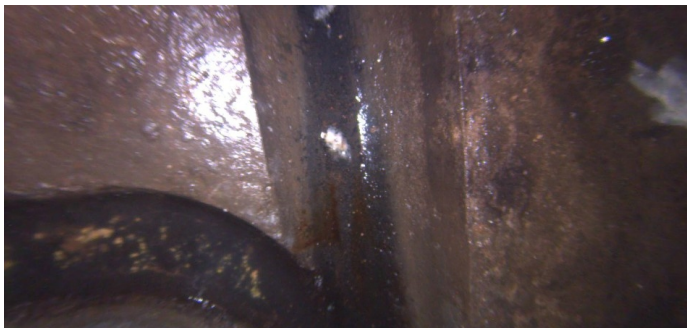
Code: **MGO**
Description: **General Observation**

Distance (ft): **4.0**
Structural Grade: **0**
O&M Grade: **0**
Clock Start/From:
Clock To:
1st Value:
2nd Value:
Value Percent:
Step: **NO**
Remarks: **Ins. Comp.**
