Manhole Inspection Report

Date:	04/06/2018	Weather:		Coding:	RZMACP
MH#:	M-608-022	Owner:	NA	Len. Surveyed:	10.5
P.O.#:		Surveyor:	John Kuglmaier	Rim to Invert:	11.5
Customer:		Cert. #:	U-1215-07002349	Wall Material:	Concrete (reinforced)

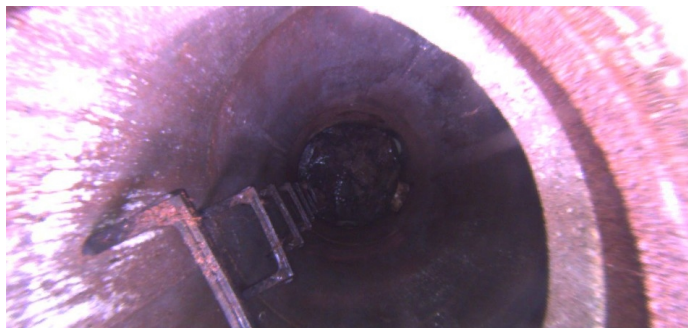
Code: **MGP**
Description: **General Photo**

Distance (ft): **.0**
Structural Grade: **0**
O&M Grade: **0**
Clock Start/From:
Clock To:
1st Value:
2nd Value:
Value Percent:
Step: **NO**
Remarks:

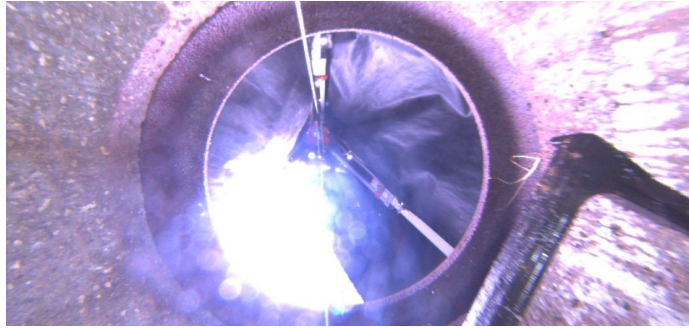
Code: **MGP**
Description: **General Photo**

Distance (ft): **2.4**
Structural Grade: **0**
O&M Grade: **0**
Clock Start/From:
Clock To:
1st Value:
2nd Value:
Value Percent:
Step: **NO**
Remarks:

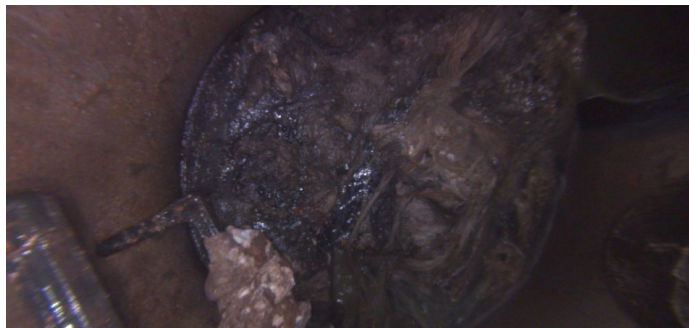
Code: **DAZ**
Description: **Deposits Attached Other**

Distance (ft): **8.4**
Structural Grade: **0**
O&M Grade: **3**
Clock Start/From: **12**
Clock To: **12**
1st Value:
2nd Value:
Value Percent: **20.000**
Step: **NO**
Remarks: **Mixed materials**

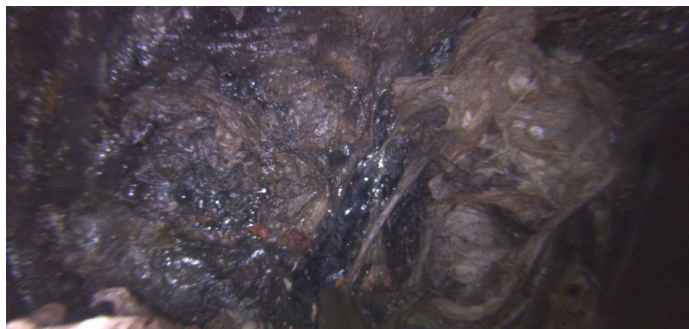
Code: **MGO**
Description: **General Observation**

Distance (ft): **9.9**
Structural Grade: **0**
O&M Grade: **0**
Clock Start/From:
Clock To:
1st Value:
2nd Value:
Value Percent:
Step: **NO**
Remarks: **Ins. Comp.**
