Manhole Inspection Report

Date:	04/08/2018	Weather:		Coding:	RZMACP
MH#:	M-608-024	Owner:	NA	Len. Surveyed:	6.8
P.O.#:		Surveyor:	John Kuglmaier	Rim to Invert:	7.3
Customer:		Cert. #:	U-1215-07002349	Wall Material:	Concrete (reinforced)

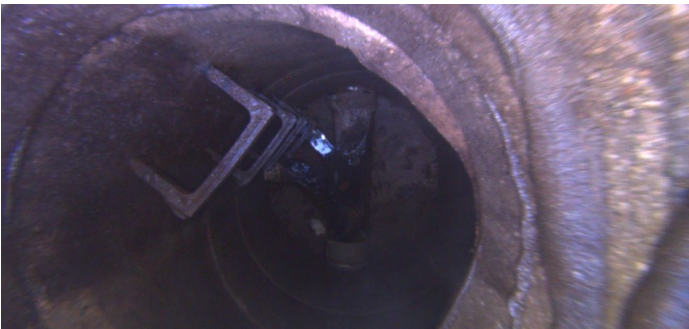
Code: **MGP**
Description: **General Photo**

Distance (ft): **.0**
Structural Grade: **0**
O&M Grade: **0**
Clock Start/From:
Clock To:
1st Value:
2nd Value:
Value Percent:
Step: **NO**
Remarks:

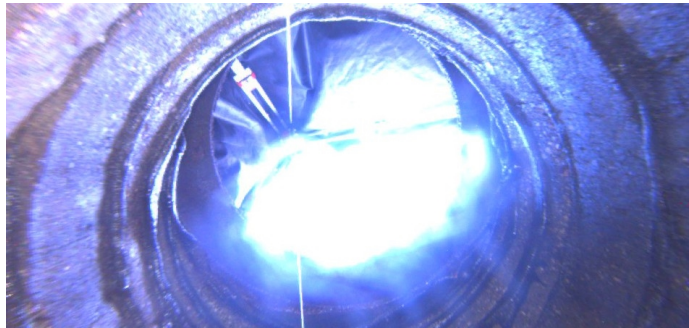
Code: **MGP**
Description: **General Photo**

Distance (ft): **2.3**
Structural Grade: **0**
O&M Grade: **0**
Clock Start/From:
Clock To:
1st Value:
2nd Value:
Value Percent:
Step: **NO**
Remarks:

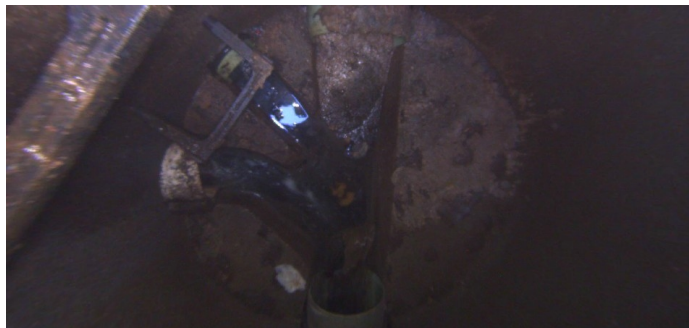
Code: **DSF**
Description: **Deposits Settled Fine**

Distance (ft): **3.7**
Structural Grade: **0**
O&M Grade: **2**
Clock Start/From: **12**
Clock To: **12**
1st Value:
2nd Value:
Value Percent: **5.000**
Step: **NO**
Remarks:

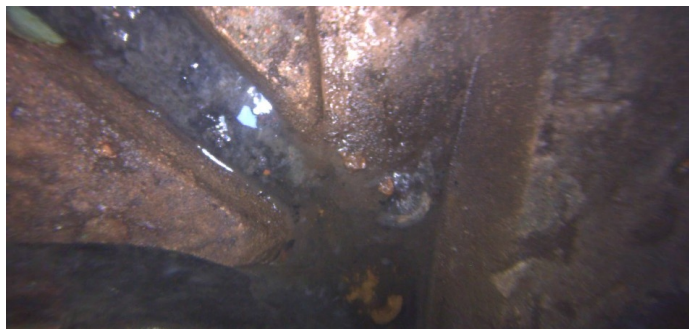
Code: **MGO**
Description: **General Observation**

Distance (ft): **6.0**
Structural Grade: **0**
O&M Grade: **0**
Clock Start/From:
Clock To:
1st Value:
2nd Value:
Value Percent:
Step: **NO**
Remarks: **Ins. Comp.**
