Manhole Inspection Report

Date:	04/06/2018	Weather:		Coding:	RZMACP
MH#:	M-608-026	Owner:	NA	Len. Surveyed:	8.1
P.O.#:		Surveyor:	John Kuglmaier	Rim to Invert:	8.7
Customer:		Cert. #:	U-1215-07002349	Wall Material:	Concrete (reinforced)

Street:	56' South of 14th St. 605' East of We	Project:	Hobart, IN
City:	Hobart, IN	GPS Northing:	0.0
Location:		GPS Easting:	0.0
Drain Area:	Southwest	GPS Accuracy:	Nearest Meter
Cover Shape:	Circular	Evidence of Surcharge:	No
Cover Size:	22.5	Potential for Runoff:	None
Comments:

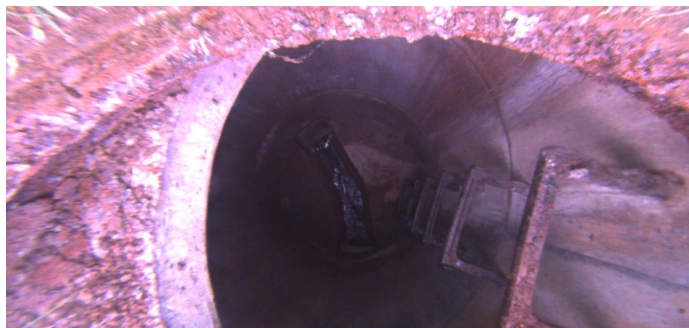
Code: **MGP**
Description: **General Photo**

Distance (ft): **.0**
Structural Grade: **0**
O&M Grade: **0**
Clock Start/From:
Clock To:
1st Value:
2nd Value:
Value Percent:
Step: **NO**
Remarks:

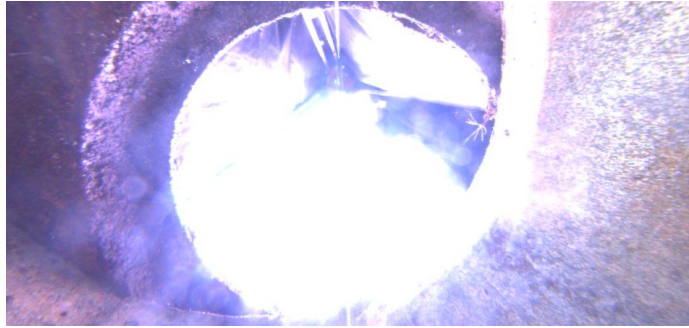
Code: **MGP**
Description: **General Photo**

Distance (ft): **2.1**
Structural Grade: **0**
O&M Grade: **0**
Clock Start/From:
Clock To:
1st Value:
2nd Value:
Value Percent:
Step: **NO**
Remarks:

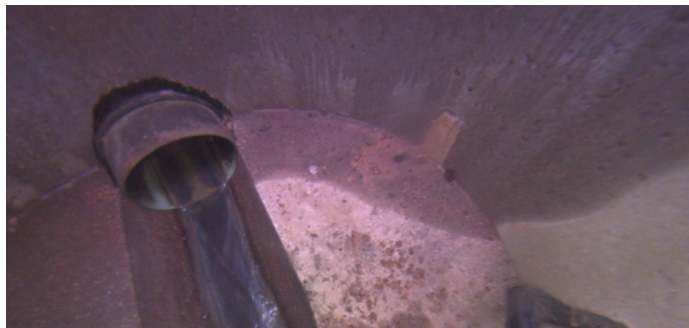
Code: **IS**
Description: **Infil Stain**

Distance (ft): **6.1**
Structural Grade: **0**
O&M Grade: **0**
Clock Start/From: **1**
Clock To:
1st Value:
2nd Value:
Value Percent:
Step: **NO**
Remarks:

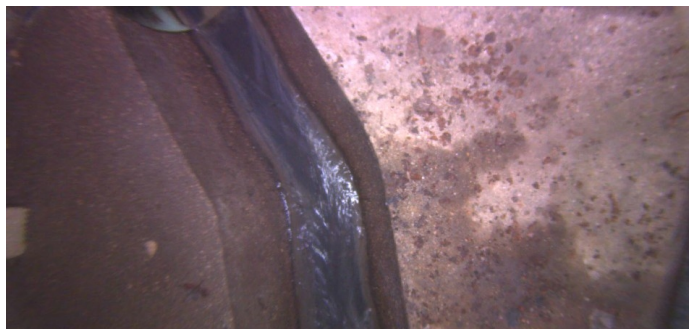
Code: **MGO**
Description: **General Observation**

Distance (ft): **6.7**
Structural Grade: **0**
O&M Grade: **0**
Clock Start/From:
Clock To:
1st Value:
2nd Value:
Value Percent:
Step: **NO**
Remarks: **Ins. Comp.**
