Manhole Inspection Report

Date:	04/08/2018	Weather:		Coding:	RZMACP
MH#:	M-608-031	Owner:	NA	Len. Surveyed:	4.1
P.O.#:		Surveyor:	John Kuglmaier	Rim to Invert:	7.9
Customer:		Cert. #:	U-1215-07002349	Wall Material:	Concrete (reinforced)

Street:	238' South of 14th St. 665' West of	Project:	Hobart, IN
City:	Hobart, IN	GPS Northing:	2904008.971
Location:		GPS Easting:	2904008.971
Drain Area:	Southwest	GPS Accuracy:	Sub-Meter
Cover Shape:	Circular	Evidence of Surcharge:	Yes
Cover Size:	22.5	Potential for Runoff:	None
Comments:

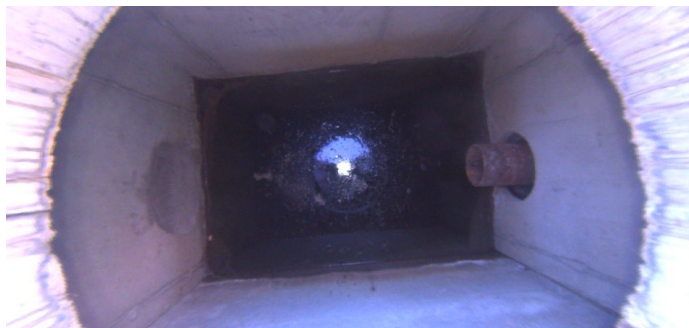
Code: **MGP**
Description: **General Photo**

Distance (ft): **.0**
Structural Grade: **0**
O&M Grade: **0**
Clock Start/From:
Clock To:
1st Value:
2nd Value:
Value Percent:
Step: **NO**
Remarks:

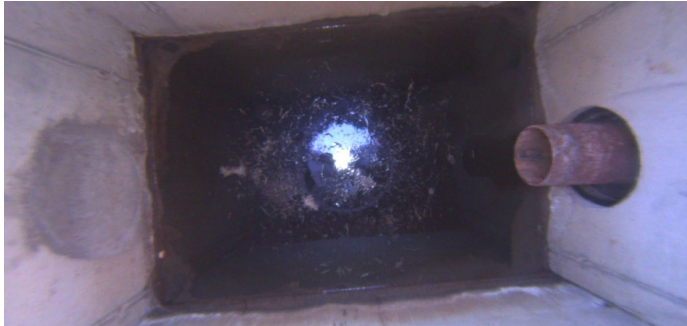
Code: **MGO**
Description: **General Observation**

Distance (ft): **1.1**
Structural Grade: **0**
O&M Grade: **0**
Clock Start/From:
Clock To:
1st Value:
2nd Value:
Value Percent:
Step: **NO**
Remarks: **Surcharge**

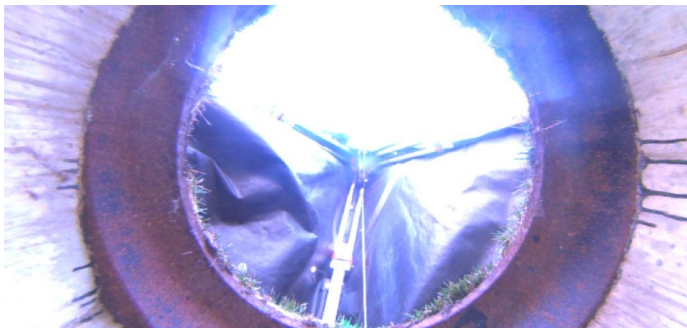
Code: **MGP**
Description: **General Photo**

Distance (ft): **1.9**
Structural Grade: **0**
O&M Grade: **0**
Clock Start/From:
Clock To:
1st Value:
2nd Value:
Value Percent:
Step: **NO**
Remarks:

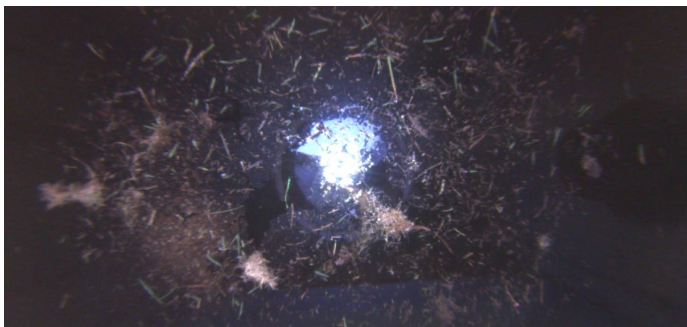
Code: **MSA**
Description: **Abandoned Survey**

Distance (ft): **3.1**
Structural Grade: **0**
O&M Grade: **0**
Clock Start/From:
Clock To:
1st Value:
2nd Value:
Value Percent:
Step: **NO**
Remarks: **Surcharge**
