Manhole Inspection Report

Date:	04/08/2018	Weather:		Coding:	RZMACP
MH#:	M-608-031A	Owner:	NA	Len. Surveyed:	4.0
P.O.#:		Surveyor:	John Kuglmaier	Rim to Invert:	7.9
Customer:		Cert. #:	U-1215-07002349	Wall Material:	Concrete (reinforced)

Street:	238' South of 14th St. 665' West of	Project:	Hobart, IN
City:	Hobart, IN	GPS Northing:	0.0
Location:		GPS Easting:	0.0
Drain Area:	Southwest	GPS Accuracy:	Nearest Meter
Cover Shape:	Circular	Evidence of Surcharge:	Yes
Cover Size:	22.5	Potential for Runoff:	None
Comments:

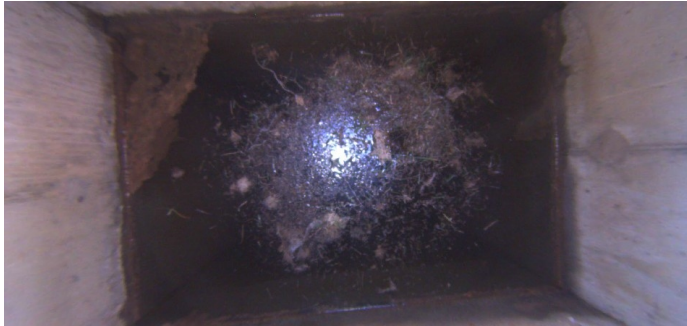
Code: **MGO**
Description: **General Observation**

Distance (ft): **1.6**
Structural Grade: **0**
O&M Grade: **0**
Clock Start/From:
Clock To:
1st Value:
2nd Value:
Value Percent:
Step: **NO**
Remarks: **Surcharge**

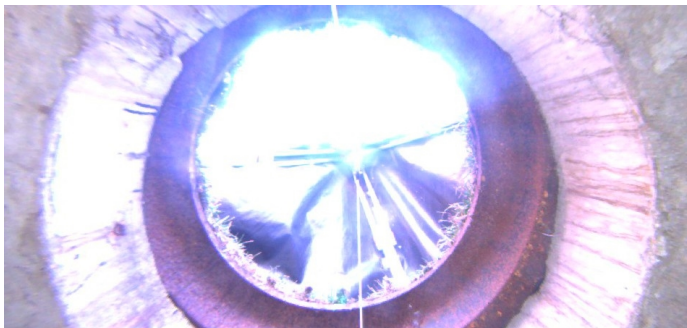
Code: **MGP**
Description: **General Photo**

Distance (ft): **2.3**
Structural Grade: **0**
O&M Grade: **0**
Clock Start/From:
Clock To:
1st Value:
2nd Value:
Value Percent:
Step: **NO**
Remarks:

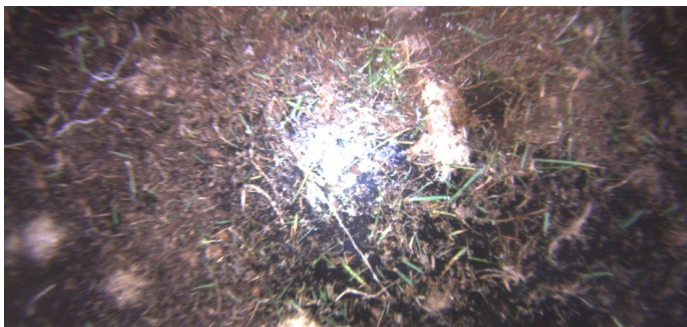
Code: **MSA**
Description: **Abandoned Survey**

Distance (ft): **3.3**
Structural Grade: **0**
O&M Grade: **0**
Clock Start/From:
Clock To:
1st Value:
2nd Value:
Value Percent:
Step: **NO**
Remarks: **Surcharge**
