Manhole Inspection Report

| MH#: | M-608-031B | Owner: | NA | Len. Surveyed: | 4.0 |

| Street: | 238' South of 14th St. 665' West of | Project: | Hobart, IN |

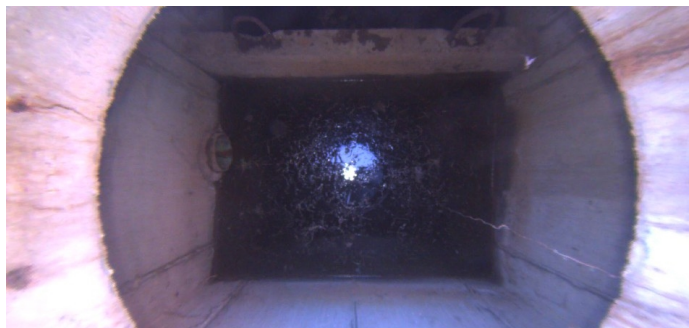
Code: **MGP**
Description: **General Photo**

Distance (ft): **.0**
Structural Grade: **0**
O&M Grade: **0**
Clock Start/From:
Clock To:
1st Value:
2nd Value:
Value Percent:
Step: **NO**
Remarks:

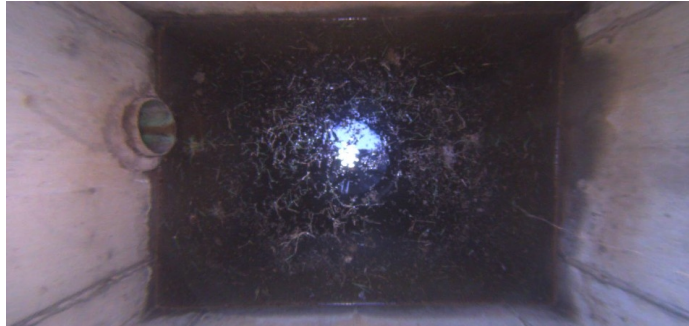
Code: **MGO**
Description: **General Observation**

Distance (ft): **1.5**
Structural Grade: **0**
O&M Grade: **0**
Clock Start/From:
Clock To:
1st Value:
2nd Value:
Value Percent:
Step: **NO**
Remarks: **Surcharge**

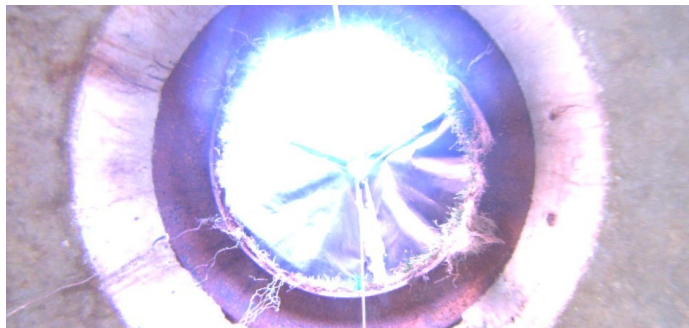
Code: **MGP**
Description: **General Photo**

Distance (ft): **2.2**
Structural Grade: **0**
O&M Grade: **0**
Clock Start/From:
Clock To:
1st Value:
2nd Value:
Value Percent:
Step: **NO**
Remarks:

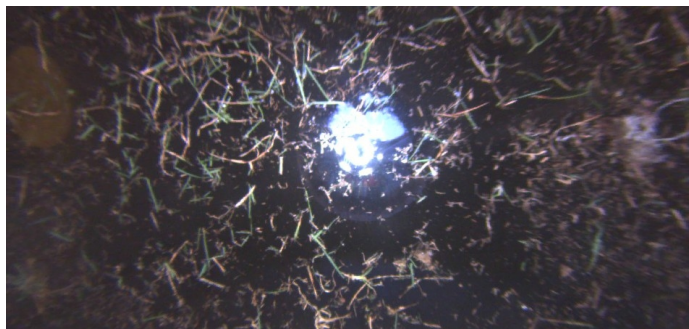
Code: **MSA**
Description: **Abandoned Survey**

Distance (ft): **3.2**
Structural Grade: **0**
O&M Grade: **0**
Clock Start/From:
Clock To:
1st Value:
2nd Value:
Value Percent:
Step: **NO**
Remarks: **Surcharge**
