Manhole Inspection Report

Date:	04/08/2018	Weather:		Coding:	RZMACP
MH#:	M-608-032	Owner:	NA	Len. Surveyed:	6.8
P.O.#:		Surveyor:	John Kuglmaier	Rim to Invert:	7.0
Customer:		Cert. #:	U-1215-07002349	Wall Material:	Concrete (reinforced)

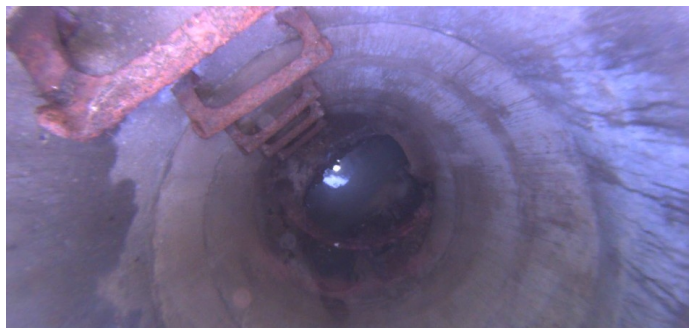
Code: **MGP**
Description: **General Photo**

Distance (ft): **.0**
Structural Grade: **0**
O&M Grade: **0**
Clock Start/From:
Clock To:
1st Value:
2nd Value:
Value Percent:
Step: **NO**
Remarks:

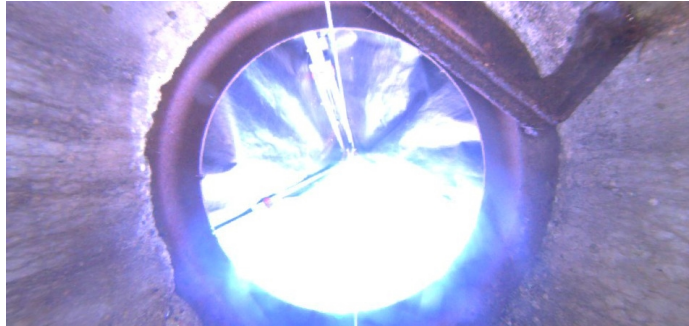
Code: **MGP**
Description: **General Photo**

Distance (ft): **2.0**
Structural Grade: **0**
O&M Grade: **0**
Clock Start/From:
Clock To:
1st Value:
2nd Value:
Value Percent:
Step: **NO**
Remarks:

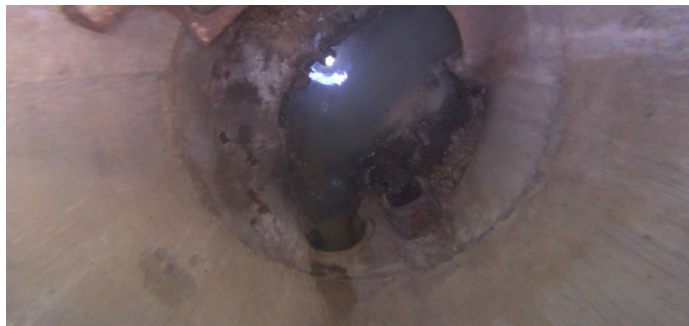
Code: **IS**
Description: **Infil Stain**

Distance (ft): **2.7**
Structural Grade: **0**
O&M Grade: **0**
Clock Start/From: **6**
Clock To:
1st Value:
2nd Value:
Value Percent:
Step: **NO**
Remarks:

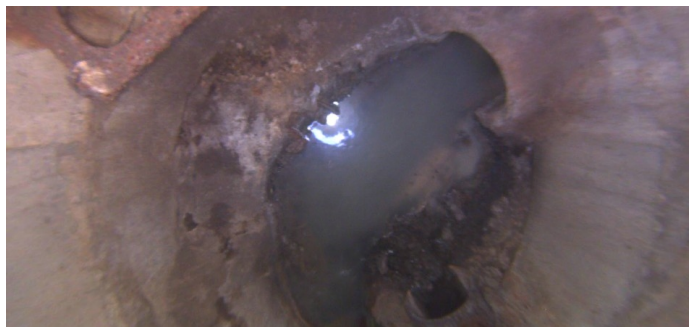
Code: **DAZ**
Description: **Deposits Attached Other**

Distance (ft): **3.7**
Structural Grade: **0**
O&M Grade: **2**
Clock Start/From: **12**
Clock To: **12**
1st Value:
2nd Value:
Value Percent: **5.000**
Step: **NO**
Remarks: **Mixed materials**

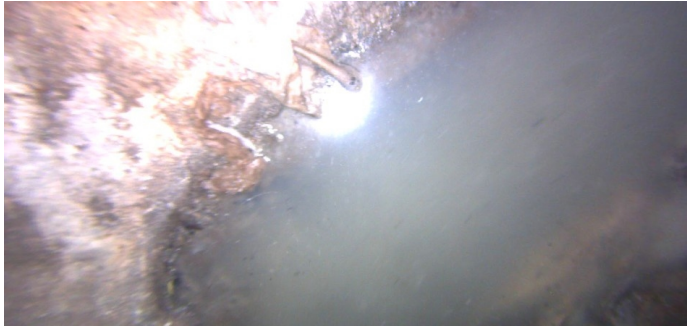
Code:	MGO
Description:	General Observation
Distance (ft):	5.9
Structural Grade:	0
O&M Grade:	0
Clock Start/From:	
Clock To:	
1st Value:	
2nd Value:	
Value Percent:	
Step:	NO
Remarks:	Ins. Comp.
