Manhole Inspection Report

Date:	04/08/2018	Weather:		Coding:	RZMACP
MH#:	M-608-033	Owner:	NA	Len. Surveyed:	4.0
P.O.#:		Surveyor:	John Kuglmaier	Rim to Invert:	4.6
Customer:		Cert. #:	U-1215-07002349	Wall Material:	Concrete (reinforced)

Street:	175' South of 14th St. 418' West of	Project:	Hobart, IN
City:	Hobart, IN	GPS Northing:	2904243.397
Location:		GPS Easting:	2904243.397
Drain Area:	Southwest	GPS Accuracy:	Sub-Meter
Cover Shape:	Circular	Evidence of Surcharge:	No
Cover Size:	22.5	Potential for Runoff:	None
Comments:

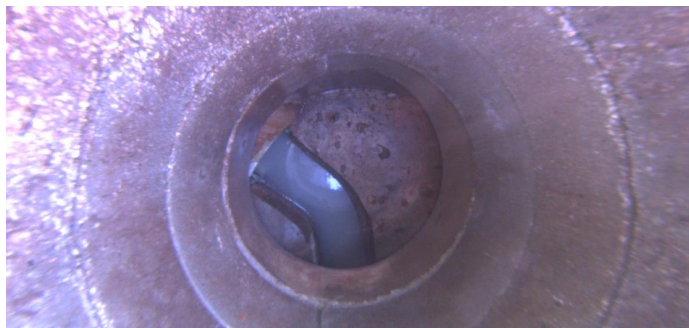
Code: **MGP**
Description: **General Photo**

Distance (ft): **.0**
Structural Grade: **0**
O&M Grade: **0**
Clock Start/From:
Clock To:
1st Value:
2nd Value:
Value Percent:
Step: **NO**
Remarks:

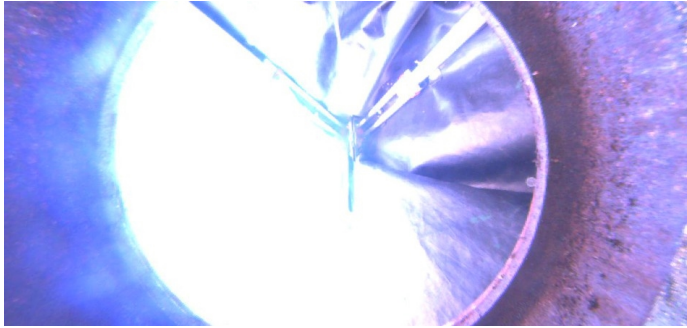
Code: **MGP**
Description: **General Photo**

Distance (ft): **1.5**
Structural Grade: **0**
O&M Grade: **0**
Clock Start/From:
Clock To:
1st Value:
2nd Value:
Value Percent:
Step: **NO**
Remarks:

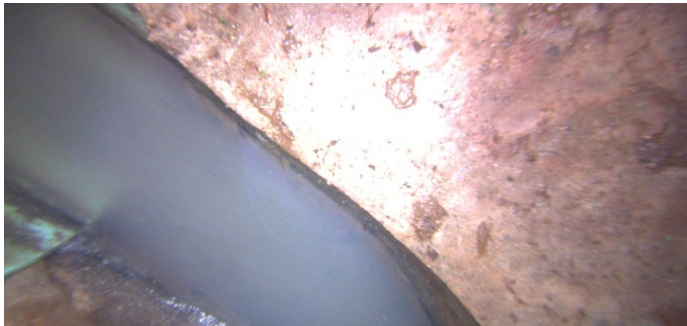
Code: **MGO**
Description: **General Observation**

Distance (ft): **3.3**
Structural Grade: **0**
O&M Grade: **0**
Clock Start/From:
Clock To:
1st Value:
2nd Value:
Value Percent:
Step: **NO**
Remarks: **Ins. Comp.**
