Manhole Inspection Report

Date:	04/06/2018	Weather:		Coding:	RZMACP
MH#:	M-608-036	Owner:	NA	Len. Surveyed:	3.3
P.O.#:		Surveyor:	John Kuglmaier	Rim to Invert:	6.0
Customer:		Cert. #:	U-1215-07002349	Wall Material:	Concrete (reinforced)

Street:	255' North of 61st Ave. 237' East of	Project:	Hobart, IN
City:	Hobart, IN	GPS Northing:	0.0
Location:		GPS Easting:	0.0
Drain Area:	Southwest	GPS Accuracy:	Nearest Meter
Cover Shape:	Circular	Evidence of Surcharge:	No
Cover Size:	22.5	Potential for Runoff:	None
Comments:

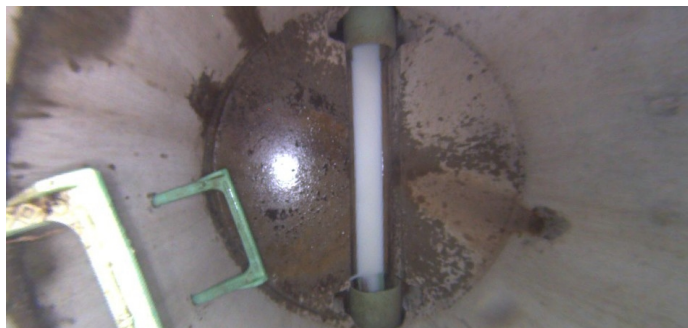
Code: **MGP**
Description: **General Photo**

Distance (ft): **.0**
Structural Grade: **0**
O&M Grade: **0**
Clock Start/From:
Clock To:
1st Value:
2nd Value:
Value Percent:
Step: **NO**
Remarks:

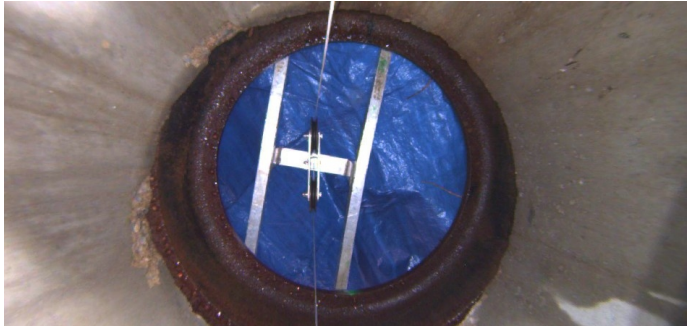
Code: **MGP**
Description: **General Photo**

Distance (ft): **.4**
Structural Grade: **0**
O&M Grade: **0**
Clock Start/From:
Clock To:
1st Value:
2nd Value:
Value Percent:
Step: **NO**
Remarks:

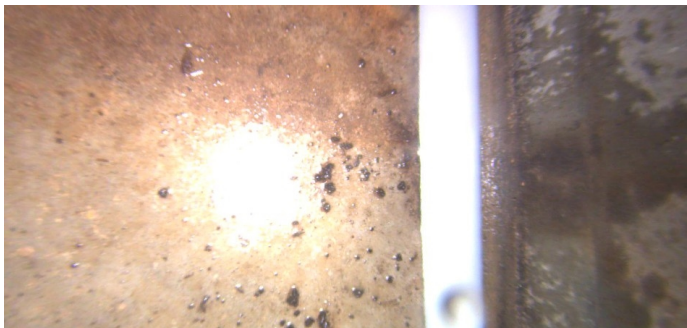
Code: **MGO**
Description: **General Observation**

Distance (ft): **2.9**
Structural Grade: **0**
O&M Grade: **0**
Clock Start/From:
Clock To:
1st Value:
2nd Value:
Value Percent:
Step: **NO**
Remarks: **Ins. Comp.**
