Manhole Inspection Report

Date:	04/06/2018	Weather:		Coding:	RZMACP
MH#:	M-608-037	Owner:	NA	Len. Surveyed:	6.8
P.O.#:		Surveyor:	John Kuglmaier	Rim to Invert:	7.5
Customer:		Cert. #:	U-1215-07002349	Wall Material:	Concrete (reinforced)

Street:	259' North of 61st Ave. 38' East of	Project:	Hobart, IN
City:	Hobart, IN	GPS Northing:	0.0
Location:		GPS Easting:	0.0
Drain Area:	Southwest	GPS Accuracy:	Nearest Meter
Cover Shape:	Circular	Evidence of Surcharge:	No
Cover Size:	22.5	Potential for Runoff:	None
Comments:

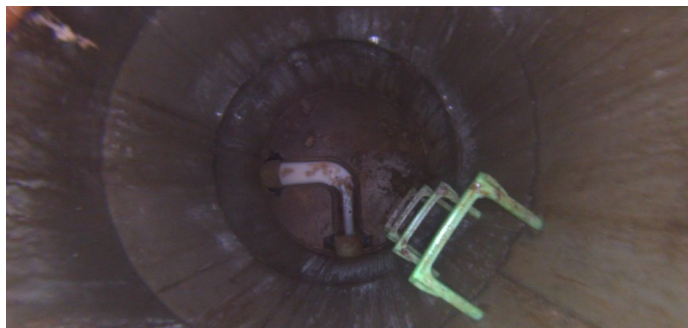
Code: **MGP**
Description: **General Photo**

Distance (ft): **.0**
Structural Grade: **0**
O&M Grade: **0**
Clock Start/From:
Clock To:
1st Value:
2nd Value:
Value Percent:
Step: **NO**
Remarks:

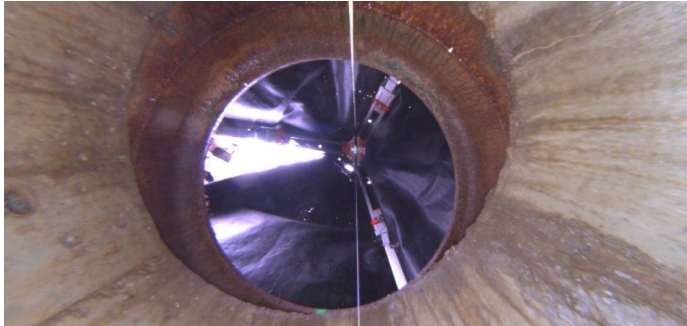
Code: **MGP**
Description: **General Photo**

Distance (ft): **2.3**
Structural Grade: **0**
O&M Grade: **0**
Clock Start/From:
Clock To:
1st Value:
2nd Value:
Value Percent:
Step: **NO**
Remarks:

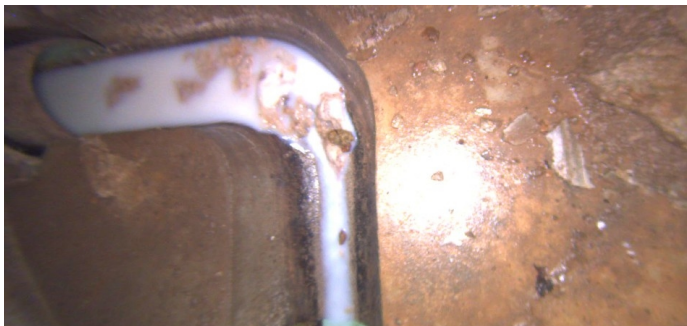
Code: **MGO**
Description: **General Observation**

Distance (ft): **6.0**
Structural Grade: **0**
O&M Grade: **0**
Clock Start/From:
Clock To:
1st Value:
2nd Value:
Value Percent:
Step: **NO**
Remarks: **Ins. Comp.**
