Manhole Inspection Report

| MH#: | M-608-038 | Owner: | NA | Len. Surveyed: | 6.5 |

| Street: | 365' North of 61st Ave. 37' East of | Project: | Hobart, IN |

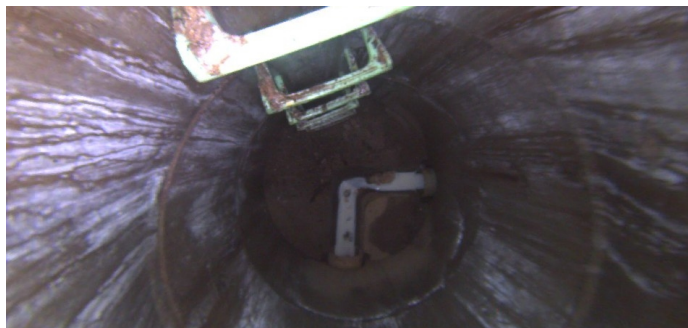
Code: **MGP**
Description: **General Photo**

Distance (ft): **.0**
Structural Grade: **0**
O&M Grade: **0**
Clock Start/From:
Clock To:
1st Value:
2nd Value:
Value Percent:
Step: **NO**
Remarks:

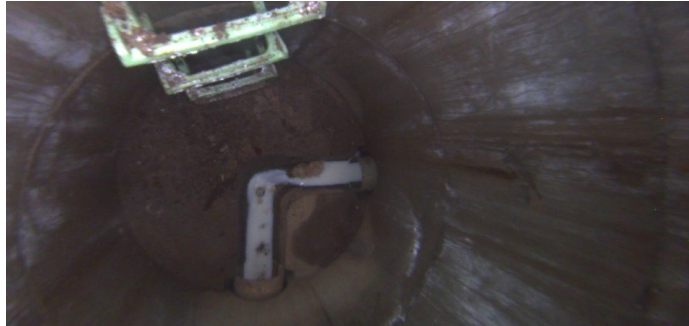
Code: **IS**
Description: **Infil Stain**

Distance (ft): **1.9**
Structural Grade: **0**
O&M Grade: **0**
Clock Start/From: **3**
Clock To:
1st Value:
2nd Value:
Value Percent:
Step: **NO**
Remarks:

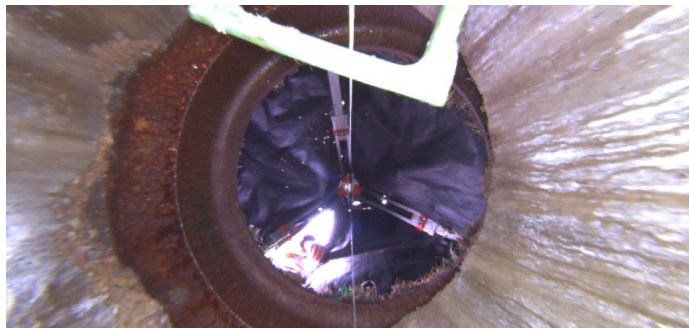
Code: **MGP**
Description: **General Photo**

Distance (ft): **2.2**
Structural Grade: **0**
O&M Grade: **0**
Clock Start/From:
Clock To:
1st Value:
2nd Value:
Value Percent:
Step: **NO**
Remarks:

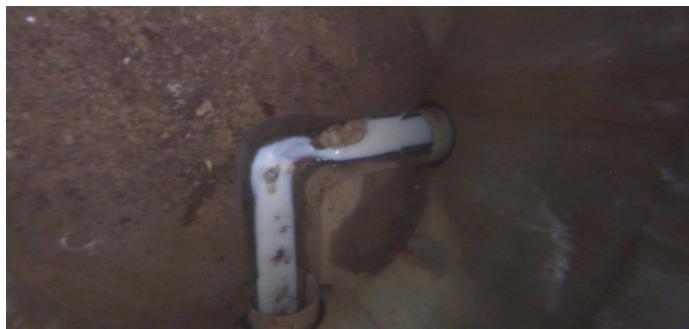
Code: **IS**
Description: **Infil Stain**

Distance (ft): **4.4**
Structural Grade: **0**
O&M Grade: **0**
Clock Start/From: **4**
Clock To:
1st Value:
2nd Value:
Value Percent:
Step: **NO**
Remarks:

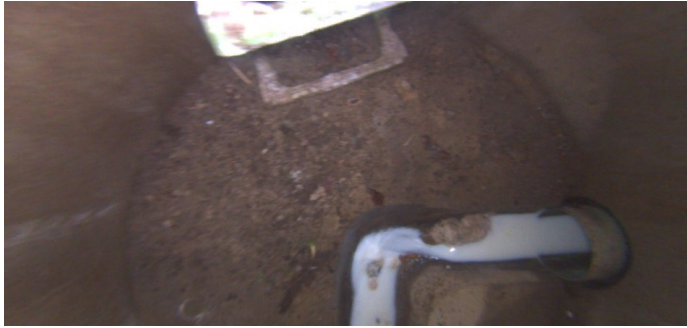
| Code: | DSF |
| Description: | Deposits Settled Fine |
| Distance (ft): | 4.6 |
| O&M Grade: | 2 |
| Value Percent: | 5.000 |

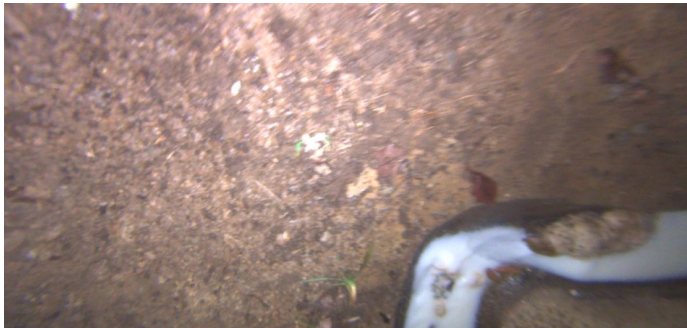
| Code: | MGO |
| Description: | General Observation |
| Distance (ft): | 6.0 |
| Remarks: | Ins. Comp. |
