Manhole Inspection Report

Date:	04/06/2018	Weather:		Coding:	RZMACP
MH#:	M-608-039	Owner:	NA	Len. Surveyed:	6.7
P.O.#:		Surveyor:	John Kuglmaier	Rim to Invert:	7.5
Customer:		Cert. #:	U-1215-07002349	Wall Material:	Concrete (reinforced)

Street:	On Washington St. 366' North of 61s	Project:	Hobart, IN
City:	Hobart, IN	GPS Northing:	0.0
Location:		GPS Easting:	0.0
Drain Area:	Southwest	GPS Accuracy:	Nearest Meter
Cover Shape:	Circular	Evidence of Surcharge:	No
Cover Size:	22.5	Potential for Runoff:	None
Comments:

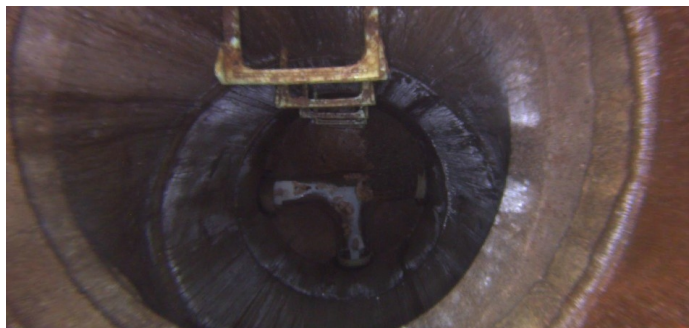
Code: **MGP**
Description: **General Photo**

Distance (ft): **.0**
Structural Grade: **0**
O&M Grade: **0**
Clock Start/From:
Clock To:
1st Value:
2nd Value:
Value Percent:
Step: **NO**
Remarks:

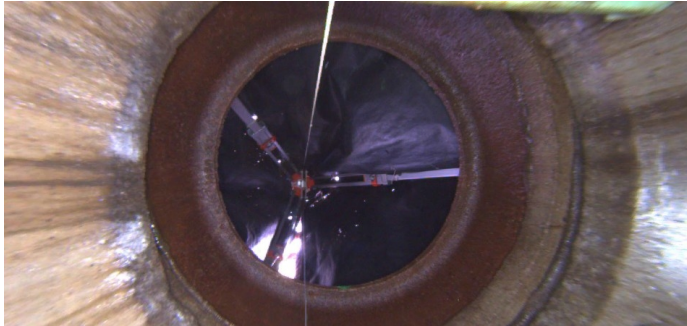
Code: **MGP**
Description: **General Photo**

Distance (ft): **2.5**
Structural Grade: **0**
O&M Grade: **0**
Clock Start/From:
Clock To:
1st Value:
2nd Value:
Value Percent:
Step: **NO**
Remarks:

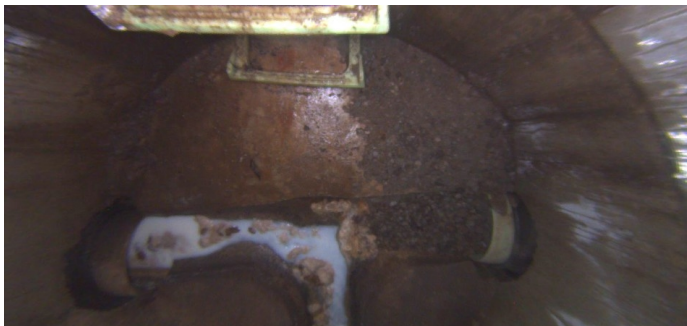
Code: **DSGV**
Description: **Deposits Settled Gravel**

Distance (ft): **4.2**
Structural Grade: **0**
O&M Grade: **2**
Clock Start/From: **1**
Clock To: **3**
1st Value:
2nd Value:
Value Percent: **5.000**
Step: **NO**
Remarks:

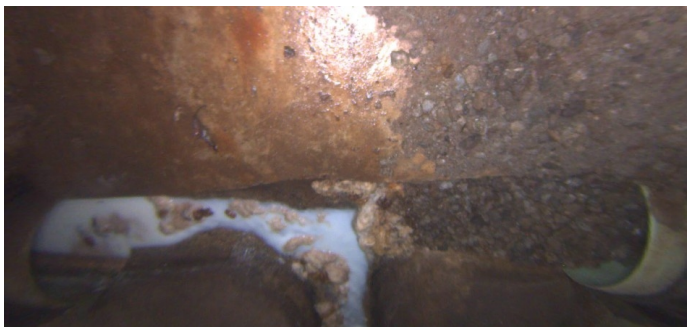
Code: **MGO**
Description: **General Observation**

Distance (ft): **5.7**
Structural Grade: **0**
O&M Grade: **0**
Clock Start/From:
Clock To:
1st Value:
2nd Value:
Value Percent:
Step: **NO**
Remarks: **Ins. Comp.**
