Manhole Inspection Report

Date:	04/08/2018	Weather:		Coding:	RZMACP
MH#:	M-608-042	Owner:	NA	Len. Surveyed:	3.7
P.O.#:		Surveyor:	John Kuglmaier	Rim to Invert:	4.1
Customer:		Cert. #:	U-1215-07002349	Wall Material:	Concrete (reinforced)

Street:	457' South of 14th St. 284' West of	Project:	Hobart, IN
City:	Hobart, IN	GPS Northing:	2904379.152
Location:		GPS Easting:	2904379.152
Drain Area:	Southwest	GPS Accuracy:	Sub-Meter
Cover Shape:	Circular	Evidence of Surcharge:	No
Cover Size:	22.5	Potential for Runoff:	None
Comments:

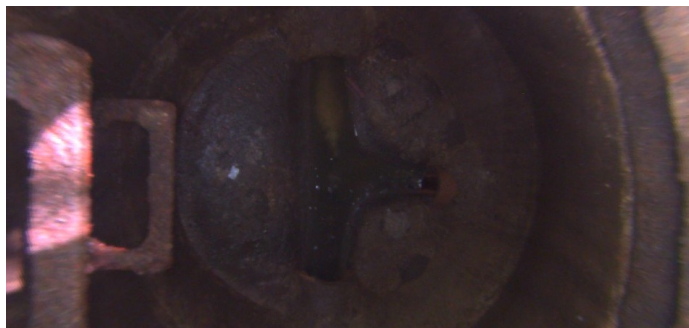
Code: **MGP**
Description: **General Photo**

Distance (ft): **.0**
Structural Grade: **0**
O&M Grade: **0**
Clock Start/From:
Clock To:
1st Value:
2nd Value:
Value Percent:
Step: **NO**
Remarks:

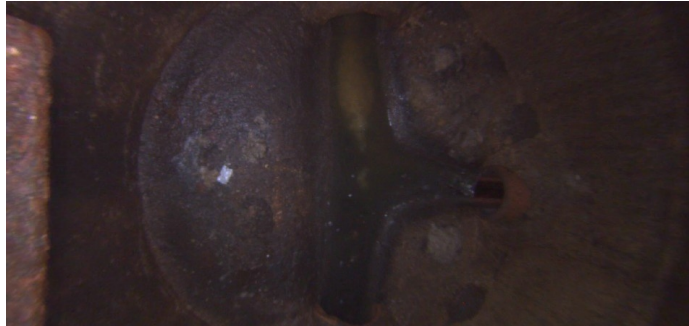
Code: **DSF**
Description: **Deposits Settled Fine**

Distance (ft): **1.2**
Structural Grade: **0**
O&M Grade: **2**
Clock Start/From: **12**
Clock To: **12**
1st Value:
2nd Value:
Value Percent: **5.000**
Step: **NO**
Remarks:

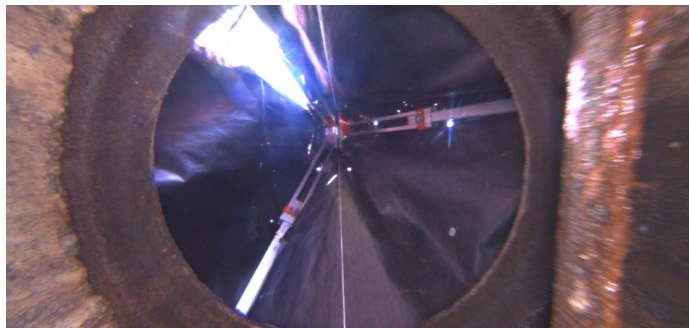
Code: **MGP**
Description: **General Photo**

Distance (ft): **1.7**
Structural Grade: **0**
O&M Grade: **0**
Clock Start/From:
Clock To:
1st Value:
2nd Value:
Value Percent:
Step: **NO**
Remarks:

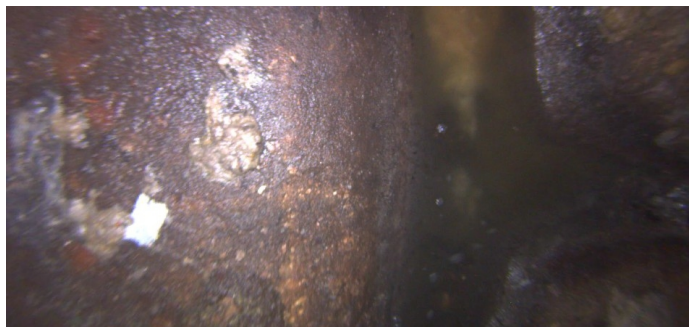
Code: **MGO**
Description: **General Observation**

Distance (ft): **3.0**
Structural Grade: **0**
O&M Grade: **0**
Clock Start/From:
Clock To:
1st Value:
2nd Value:
Value Percent:
Step: **NO**
Remarks: **Ins. Comp.**
